**VIBETEC INC.**

21st Jan 2004

6237 Exhaust Fan

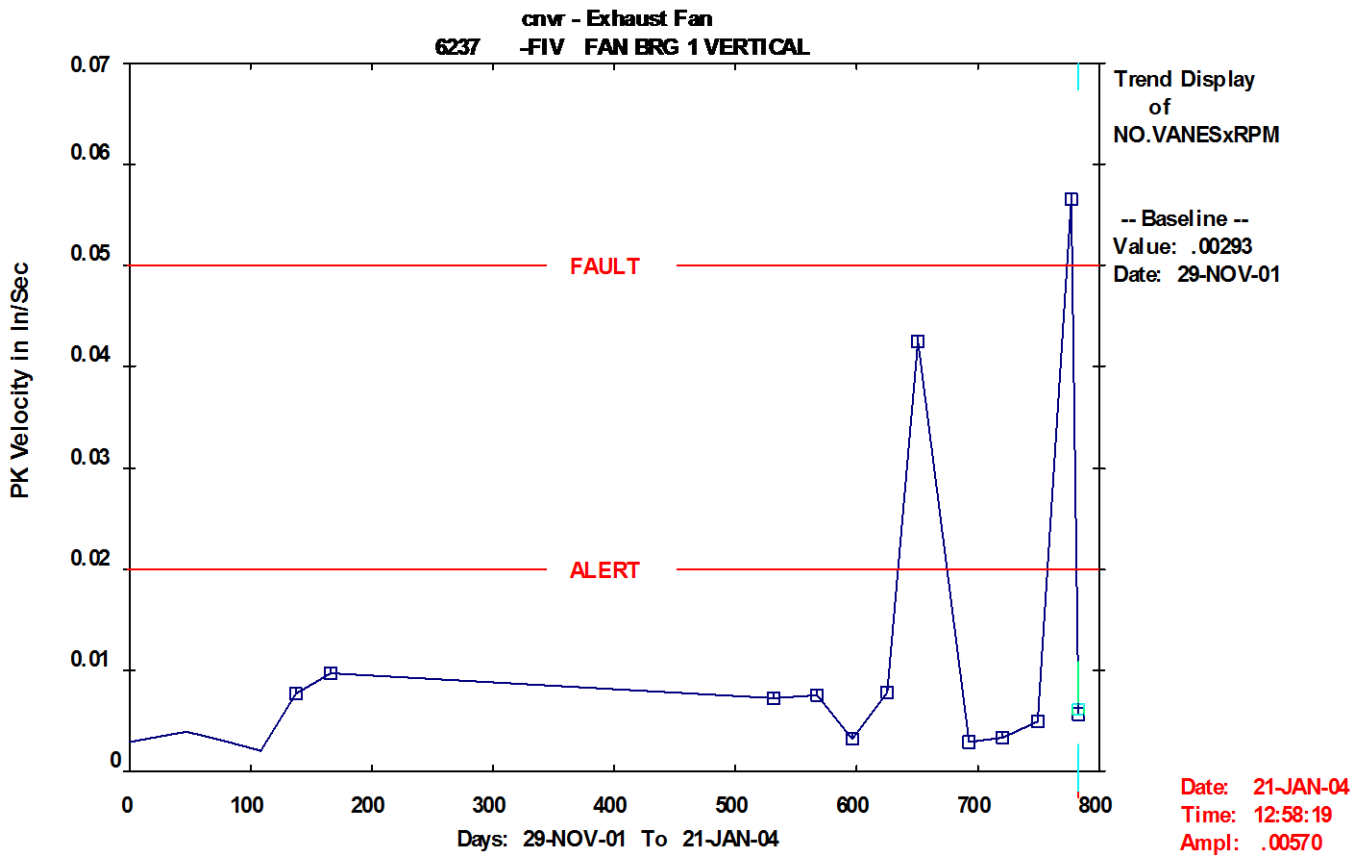
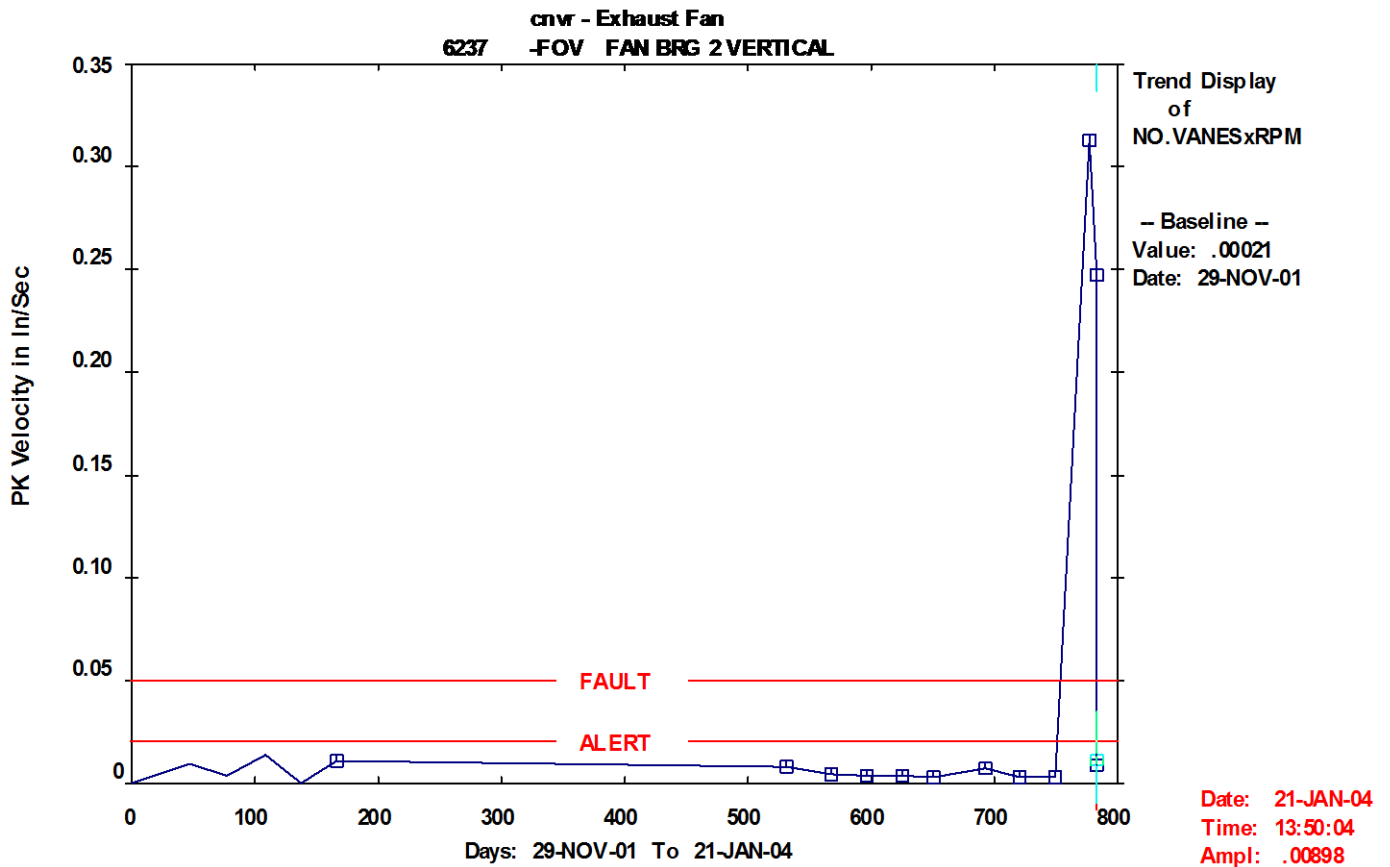
- 4/ The shaft had dropped and rubbed on the pedestal casting when the bearing failed. This caused metal from the casting to be picked up and "cold welded" to the shaft. This had not been cleaned up when the bearing was replaced and was probably the cause of the "rubbing frequency" that I found on my monthly analysis. I managed to clean the shaft up using a flapper wheel but the pedestal casting bore could not be cleaned up without dismantling fan housing and lifting the fan shaft. However, the indications from the trend plots below are that cleaning the shaft resolved the problem and eliminated the high frequency vibration issue.

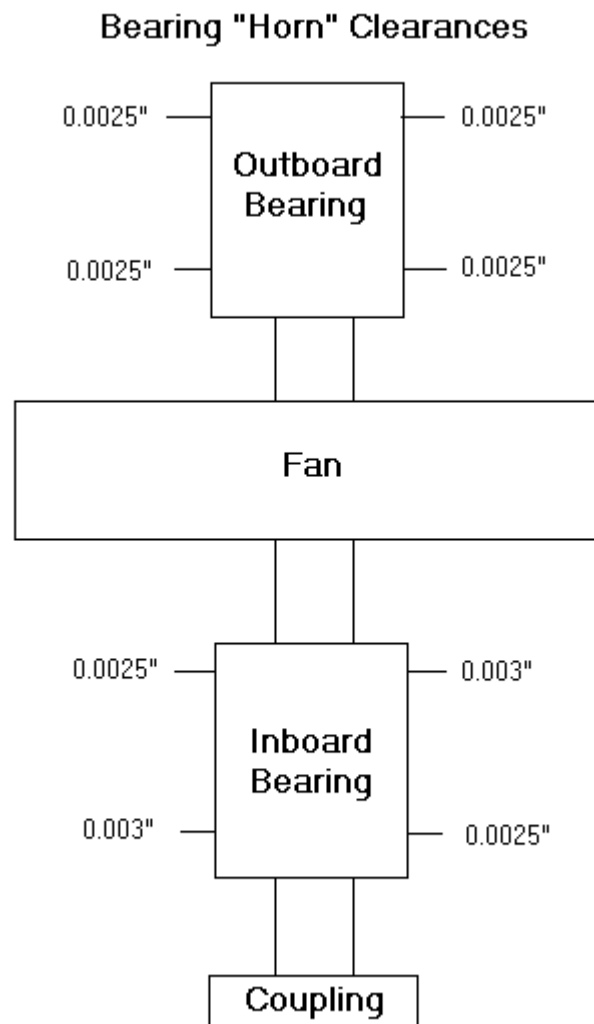
8/ Horn readings (side clearance between the journals and bottom halves of the babbitt bearings), these are important to ensure good lubrication.

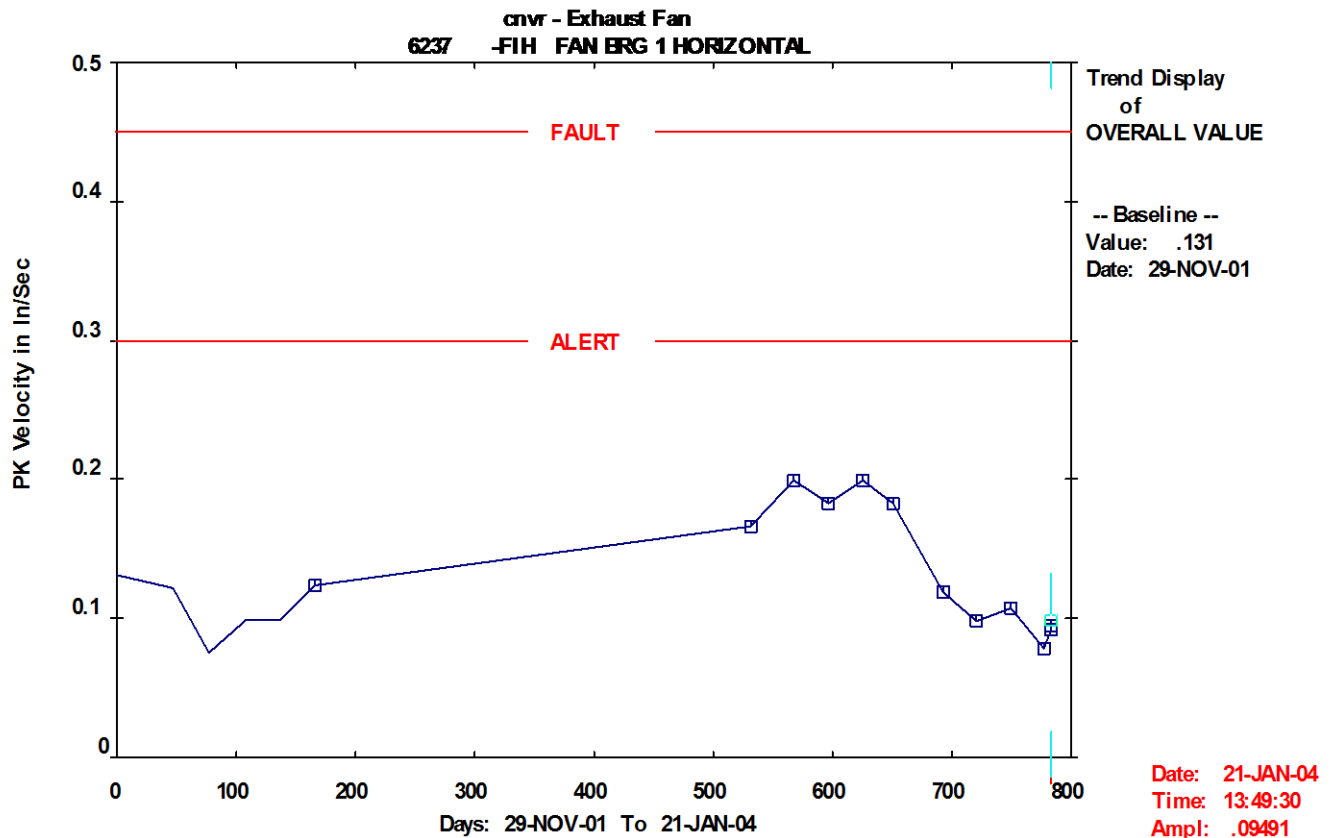
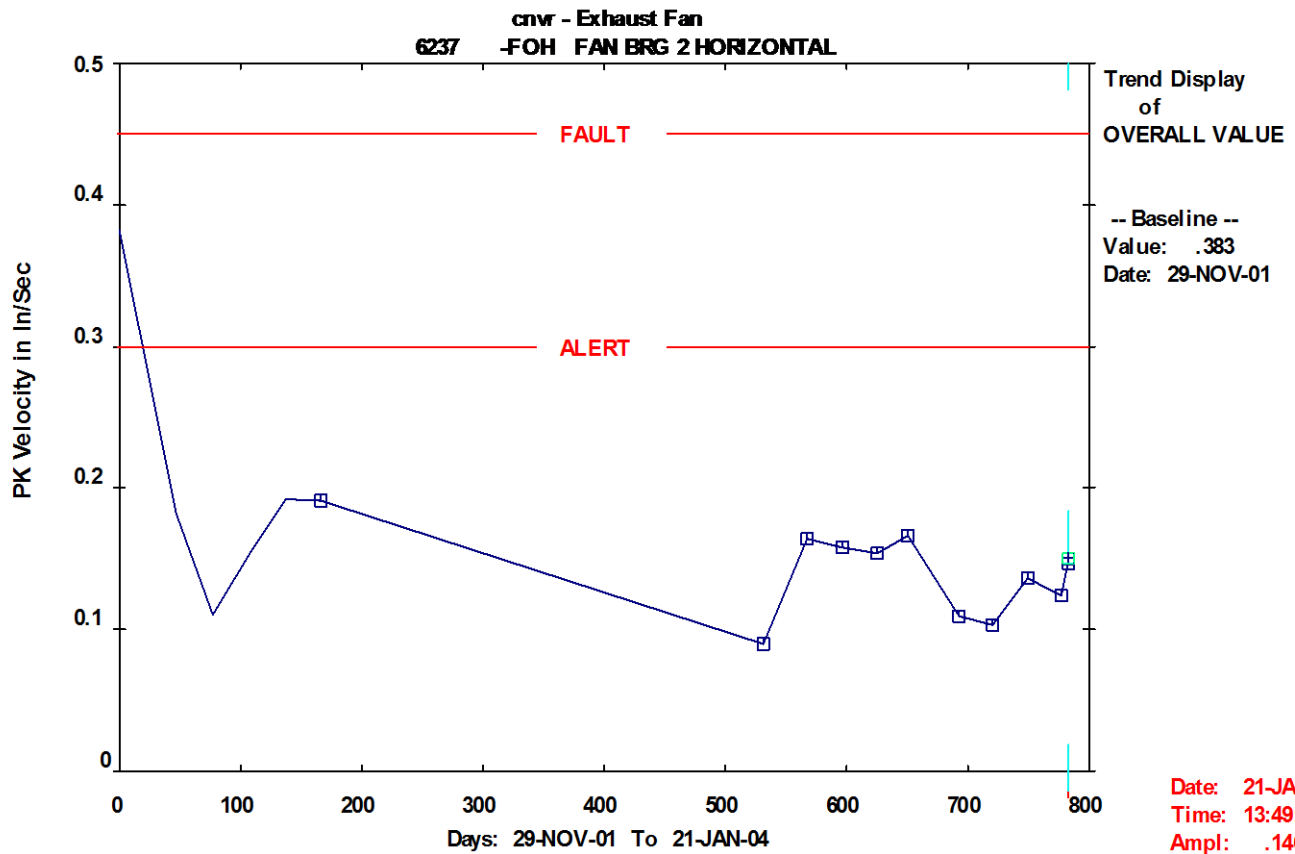
The operator thought that the vibration levels appeared high, so I made two trend plots of the overall vibration in the horizontal direction on both fan bearings. These are in the same positions and measurement parameters as your fixed transducers – (I suspect that your transducers are measuring peak to peak, where as I am measuring peak velocity therefore your measurements will be double that of mine). The plots below do not indicate anything unusual from the normal trend.
