Service Report

12.5 Mw GE Generator, Serial # 6881289,

Type ATB Manufactured 1953,
13.8Kv 523A, 3600 Rpm,
Air Cooled,
DC Field 250V / 154Amp

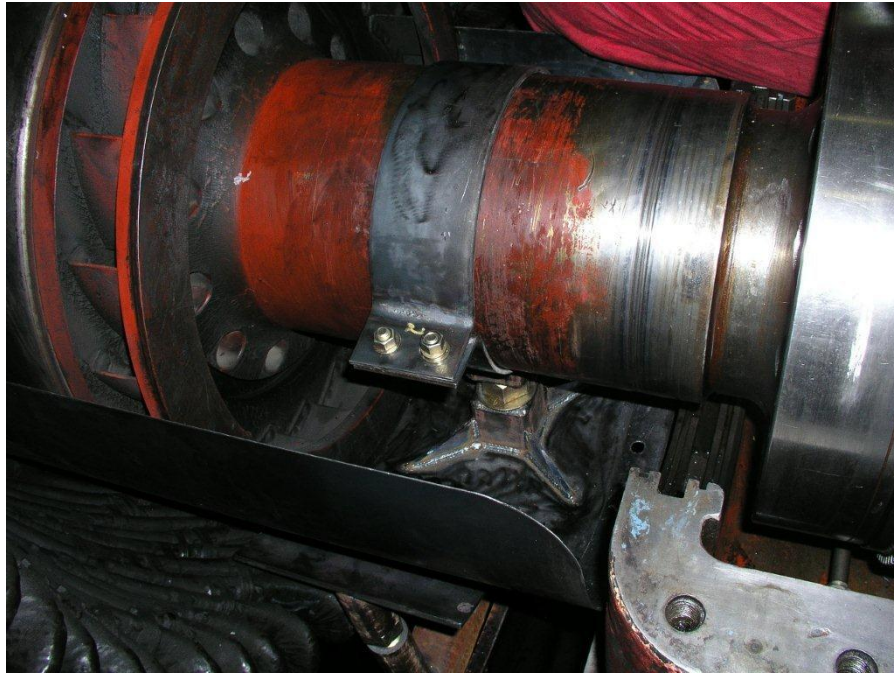
A rotor skid plate and shoe had to be fabricated when the stator bore was accessible for measuring, the rotor/ stator air gap on this machine was unusually small, this created other problems that had to be overcome i.e. normally a sturdy skid plate is installed and then the rotor is lifted enabling a support shoe to be slid past the outboard end ring and under the rotor iron core, thus preventing any contact between the inboard end ring and iron core as the rotor was extracted. With the outboard pedestal still in position the plate had to be slid onto the top of the rotor and slid around to the bottom, the thickest skid plate that we could use was only 0.125" thick. With the limited access the support shoe could not be slid into the rotor / stator air gap. Therefore an adjustable shaft clamp / shoe had to be manufactured and installed onto the inboard shaft between the cooling fan and the coupling.

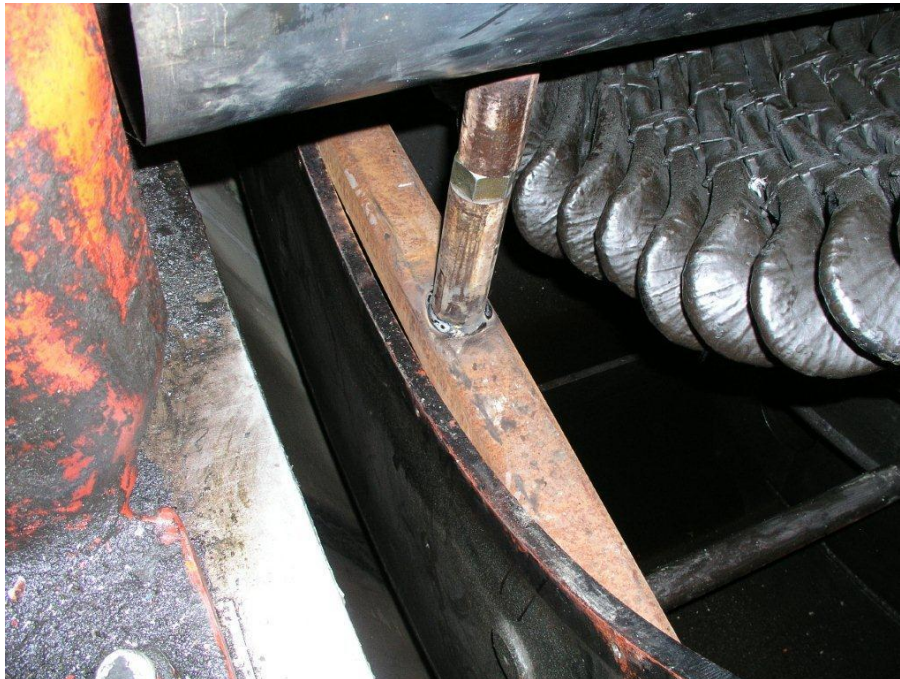
The skid plate had to be longer than normal to accommodate this. The position of the shaft clamp / shoe was approximately 18" past the iron core, the skid plate was not strong enough to support the rotor and another adjustable brace had to be fabricated to support the inboard end of the skid plate.

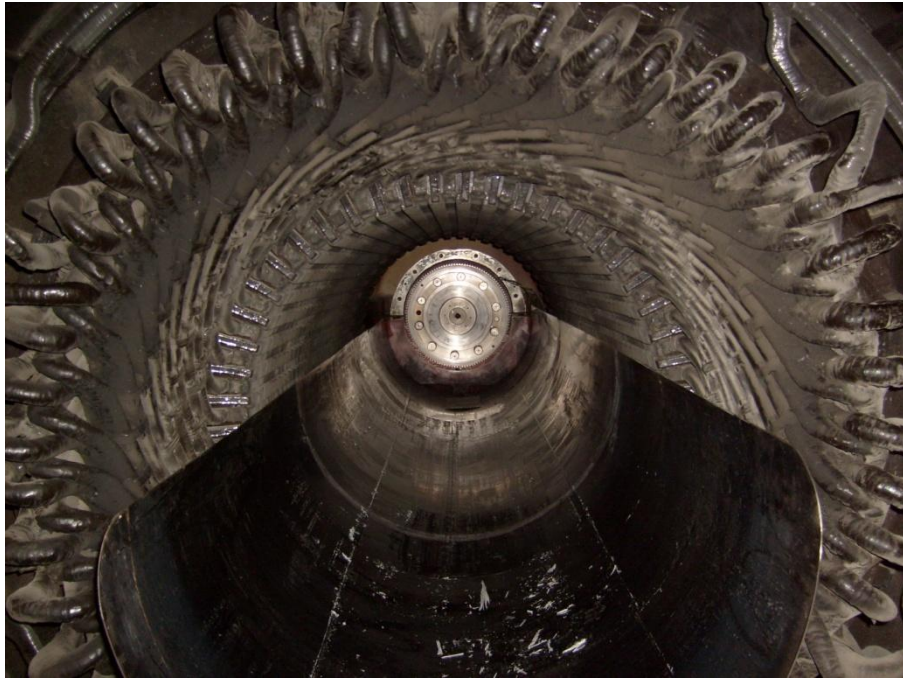
Paraffin wax was used as a lubricant on the skid plate and shoe, and the rotor was removed.

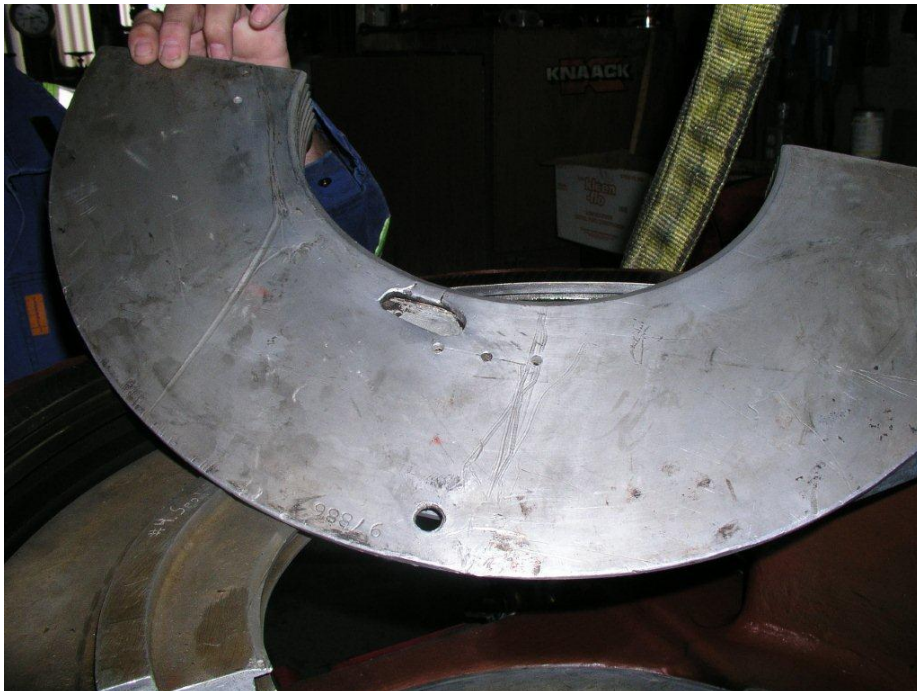
General observations, a significant amount of oil was found in the bottom of the stator frame and the inboard stator windings had a coating of oil. The stator winding blocking and bracing appeared to be in good condition, cooling vents were dirty but cleaned up well with dry ice cleaning, the wedges are the original wood wedges from 1953 and many were found to be loose (see separate report).

The reason for the oil contamination was because of a modified bottom labyrinth this was repaired with a two part “metal set” epoxy,
