VIBETEC INC.

19th June 2011

Ball Mill Pedestal Vibration

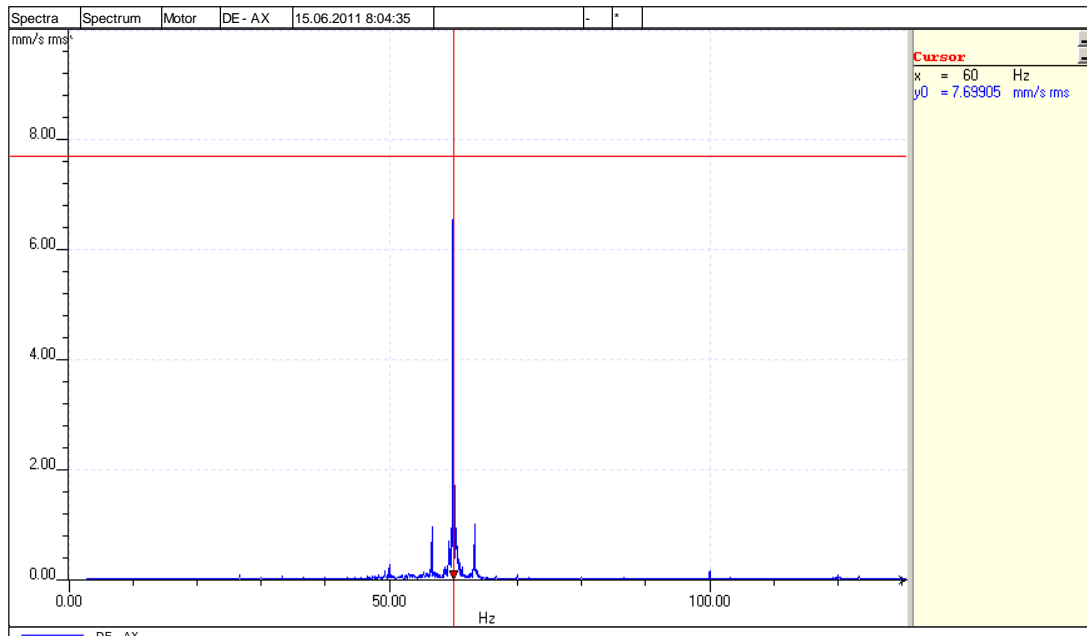
Plot #1

The highest amplitude of vibration on the ball mill drive was recorded in the axial position on the drive end motor bearing; with a amplitude of 7.7 mm/s rms at 60Hz. The source of the vibration emanates from the pinion gear mesh frequency (GMF) i.e. $18 \text{ teeth} \times 200 \text{ rpm} \div 60 = 60\text{Hz}$. However, GMF by itself is not a defect frequency. GMF will always be present in the spectrum regardless of gear condition. Its amplitude may vary, however, depending on the gear condition.

In plot #1 side bands at a frequency equal to the operating rpm (3.33Hz) are in evidence, this is another pointer to the source of vibration recorded on the DE pedestal. In gear analysis, sidebands can prove to be very valuable when diagnosing gear defects. Sidebands will show up as frequencies on either side of the GMF. The side band frequency spacing will be equal to the turning speed of either the input shaft speed or the output shaft speed. The spacing of the sidebands will be equal to the turning speed of the gear that possesses the defect. Side bands will appear most commonly because of wear, looseness and eccentricity.

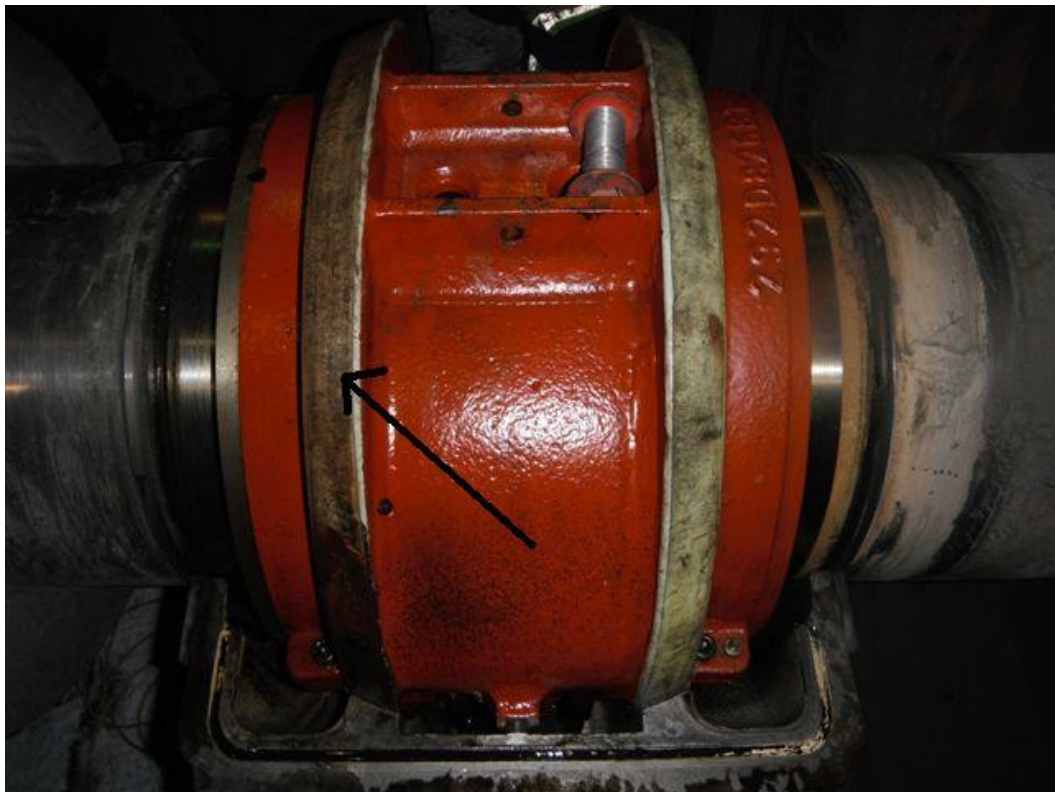
Photo #1

The motor drive end bearing diameter is worn approximately 2mm and excessively loose in the bearing pedestal, in photograph #1 the worn bearing insulation can be seen. The polished areas on the edges of both insulation rings indicate that the bearing has been rocking in the pedestal (see photo #2). The internal diameter of the drive end bearing pedestal appears to be worn. Evidence of fretting can be seen in photo #3, the amount of wear is not known because measurement was not possible because of the shaft.

It wasn't possible to determine the amount of wear in the drive end pedestal, therefore we decided to reinstall the old bearing rather than risk damaging the new one. There was heavy contact on one end of the bottom babbit shell and too much side contact; I scraped the babbit to improve the fit but due to time constraints did not re-check the fit with Persian/engineers blue. Due to the amount of outer diameter wear, the bottom babbit shell could not be rolled into place as normal. The shaft was lifted approx' 0.030" and both halves of the bearing clamped together with a soft top shim of 0.050" between the journal and top babbit. The shaft was then lowered into place, this ensured good contact along the bottom of the journal. The horn clearances were recorded @ 0.0065" ± 0.0005". The top internal babbit clearance was 0.018" at both ends.

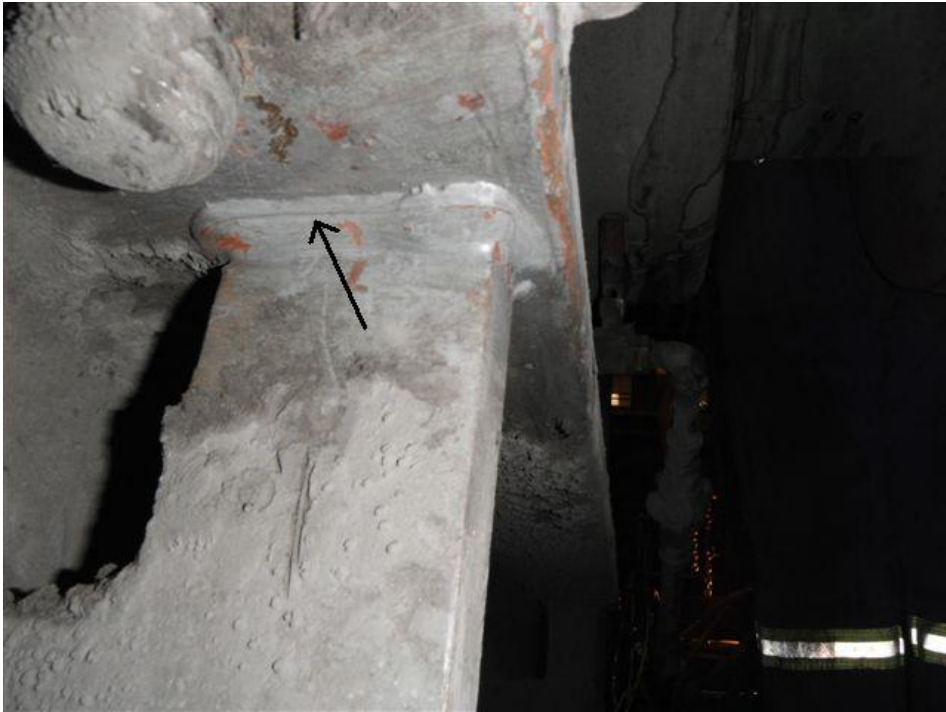
Photo #4

The webbing on the sole plate (photo #4) directly underneath the drive end motor pedestal was cracked and one sole plate hold-down bolt underneath the pedestal was loose

After re-assembly with the broken web welded, sole plate bolt tightened and old babbit bearing scraped and re-installed. The drive end motor pedestal vibration amplitude at 60Hz in the axial direction dropped to 4.85 mm/sec rms (see plot #2), I expect this amplitude to drop again when the new pedestal and babbit is installed in July.

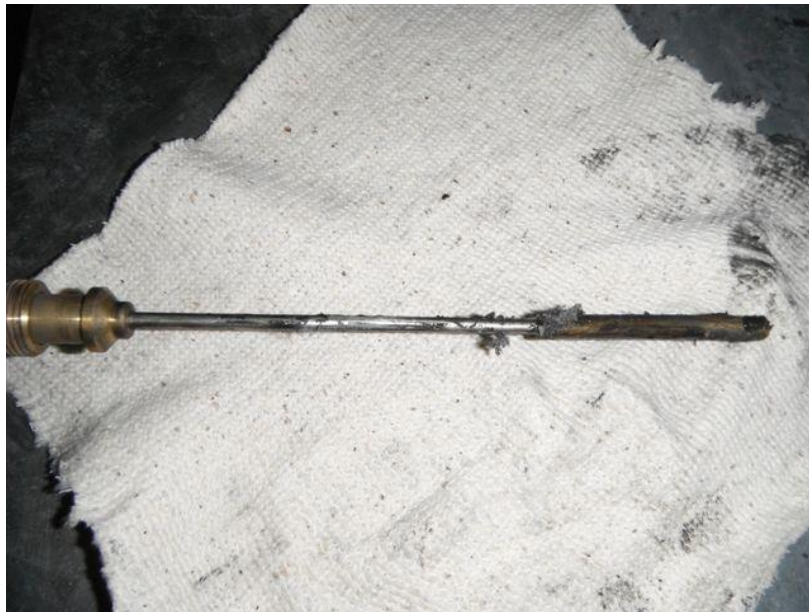
The bearing insulation resistance was $0\Omega @ 9V$ (with a fluke meter), this is allowing circulating currents to pass through the bearing affecting the viscosity of the oil and causing electrical etching/scoring of the bearing journal. The bearing temperature gauge and the RTD probes are not insulated! Therefore even if the bearing insulation had been sound the bearing would still have been grounded through the probes. Photo #5 shows contamination and dirty oil on the RTD probe.

Replace the RTD's and temperature gauge probes with an insulated type. During normal operation the opposite drive end bearing is insulated and the drive end bearing is grounded, this prevents shaft currents from circulating. The reason that both bearings are insulated is so that when the grounding bolt (located in the top of the drive end bearing pedestal) and the axial locking device are removed the insulation resistance can be measured and recorded during your regular PM's. The resistance should be a minimum of 2 MΩ @ 100V.

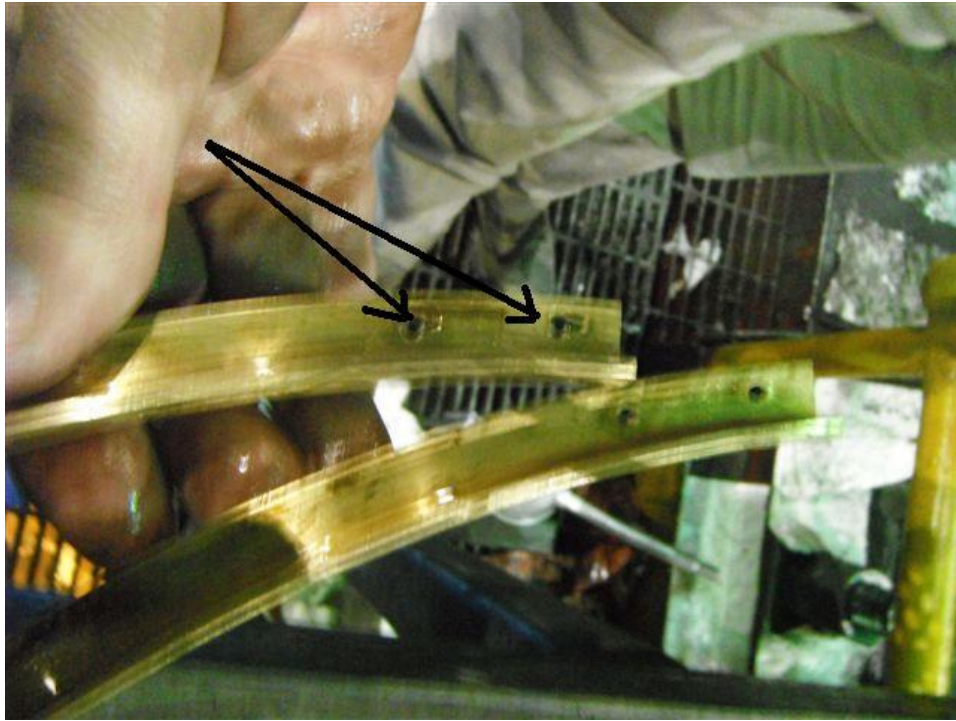
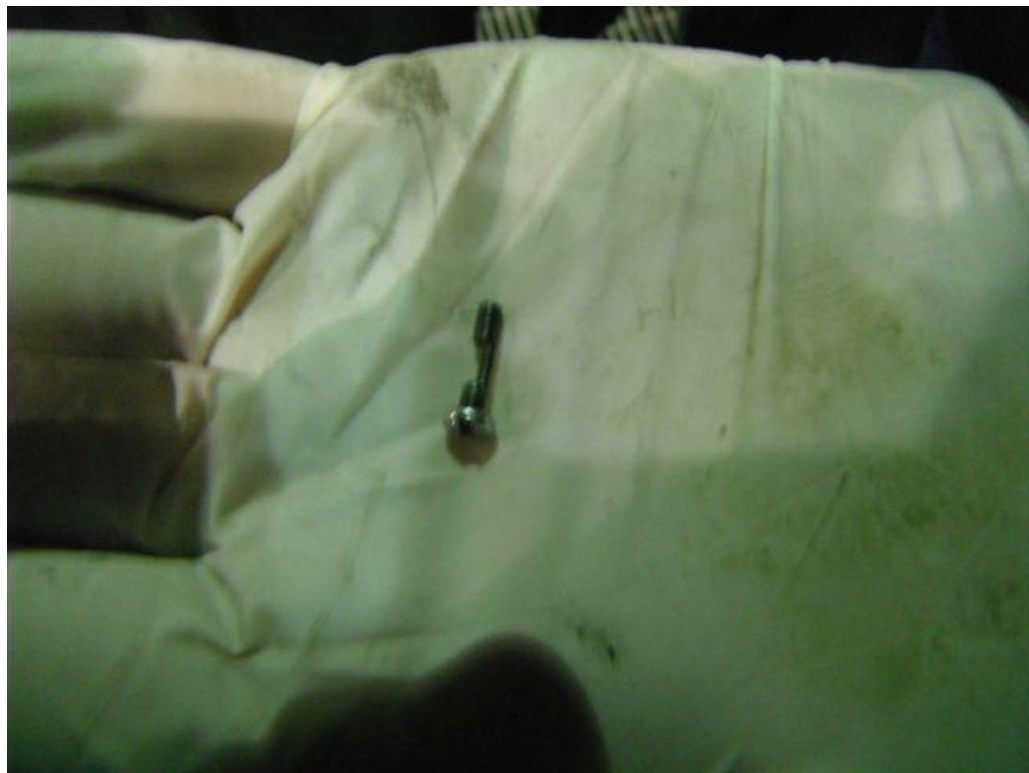
One of the motor drive end oil rings had loose screws, the holes in the brass are elongated and the screws nearly worn through, see photo # 6 & 7.

Note: in addition to the babbit bearing and pedestal replacement a new oil ring should also be installed.

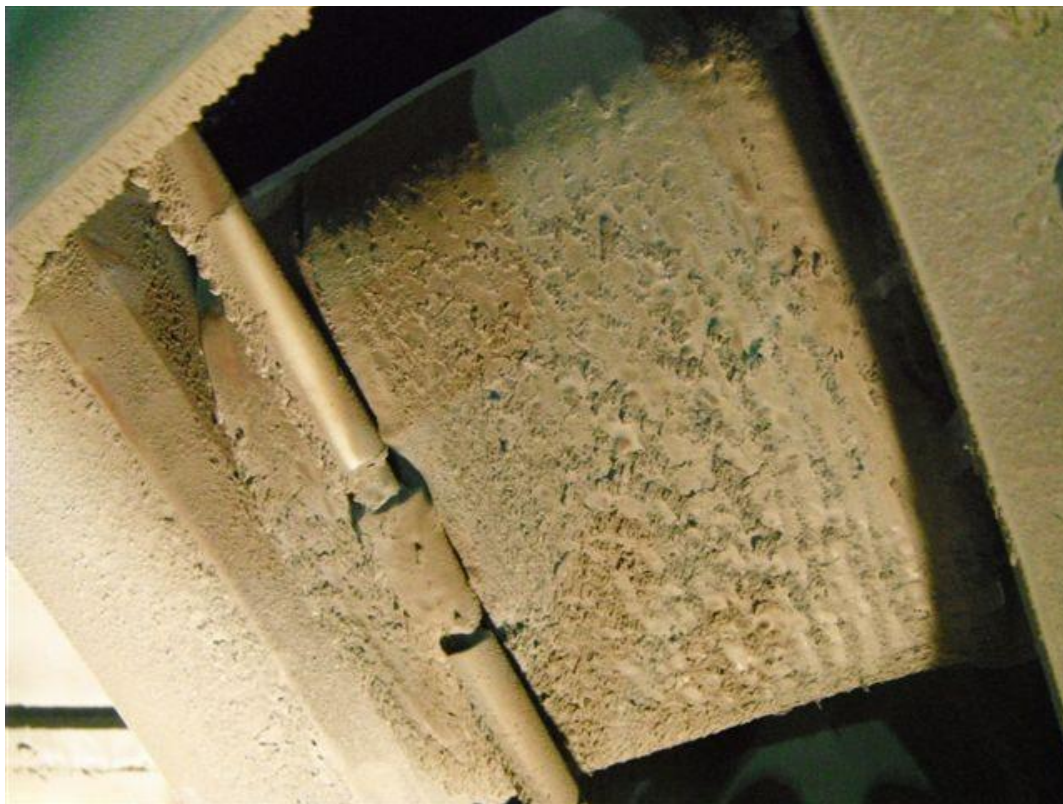
Photo #8

The motor windings are very dirty (see photo # 8), If possible it would be beneficial to clean the windings with dry-ice blasting, I have had a great deal of success cleaning windings up to 13.8Kv. With newer dry ice machines, the pressure can be turned down low enough so as not to be detrimental to the winding insulation, compressed air alone will not remove dust that is contaminated with oil. I could recommend a company but I am not sure if they could help because of the logistics of getting machines and ice to the mine site. Let me know if you would like me to pursue this avenue further for you.

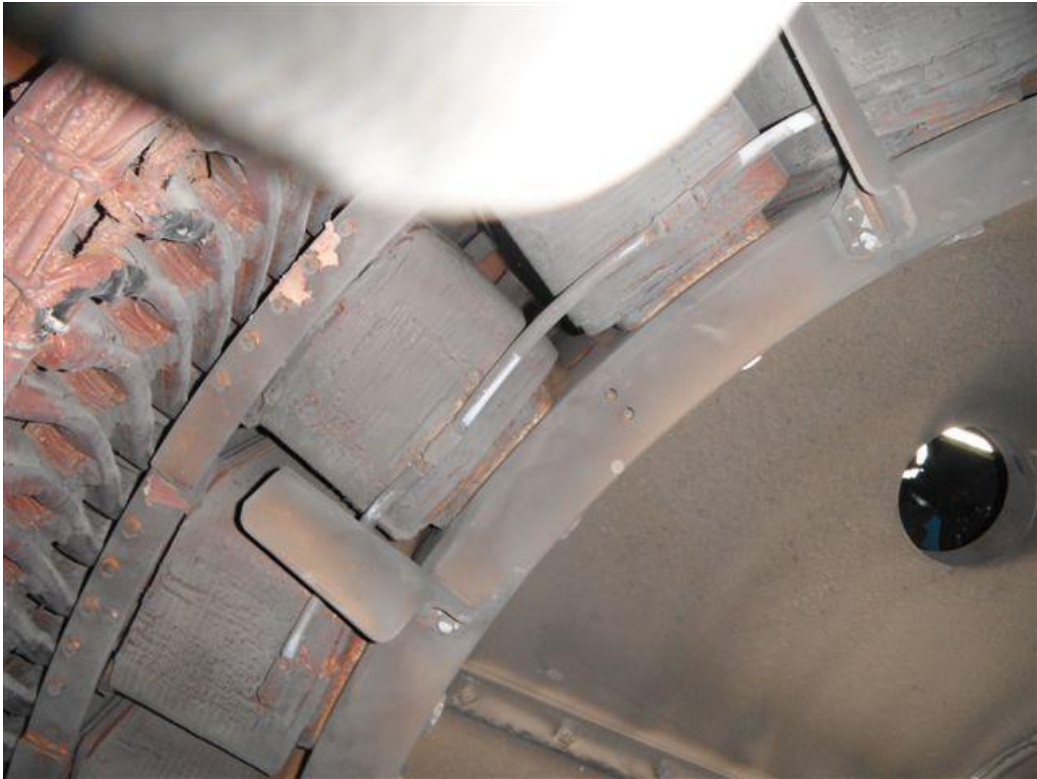
Photo #10

Varnish/paint on the amortisseur winding was peeling (see photo #10), this is not unusual and not normally a problem; however, the peeling is in the same location on both ends of the winding and at no other location. This could be just a coincidence and of no concern but it could also be an indication of winding problems. Broken rotor bars or broken rotor bar to end ring brazed joints would cause localized heating and the paint/varnish to burn. The rotor bar to end ring connection was tested using NDT equipment and no cracks were found. If the rotor bars are broken inside the pole piece the motor will lose starting torque, therefore it would be prudent to monitor and trend “run up” time. Removing a pole piece and replacing broken bars on site would be very difficult because of the weight of the pole and re-locating pole face shims during re-assembly.

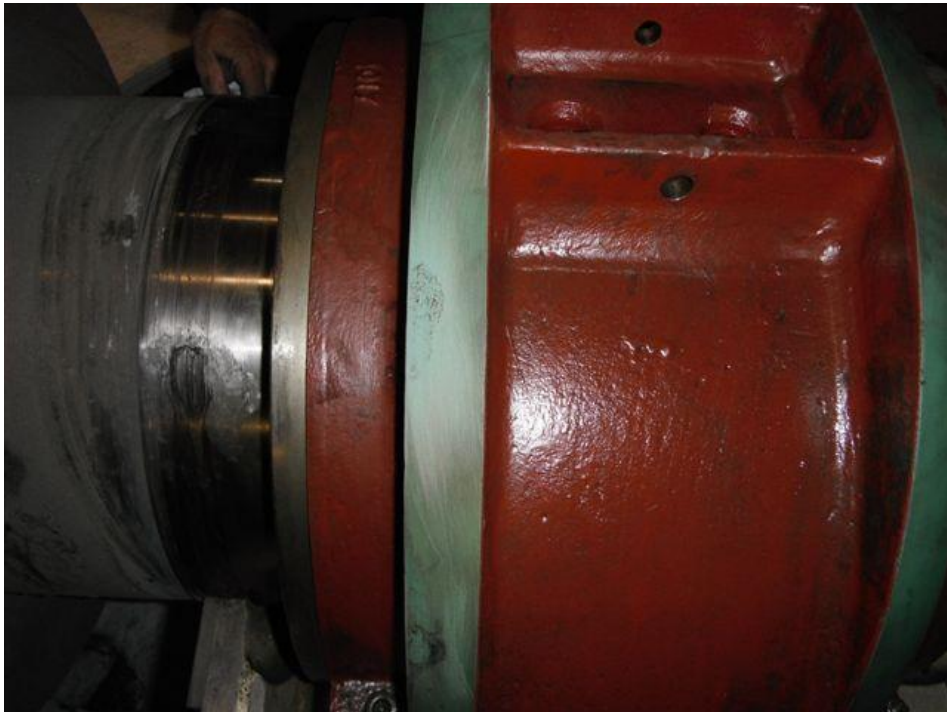
Photo #11

Metal had “picked up” on the shaft in the outboard labyrinth area (photo # 11); I checked the shaft to pedestal labyrinth clearance with feeler gauges when re-assembled and found adequate clearance, therefore the metal build up must have been from a previous failure.

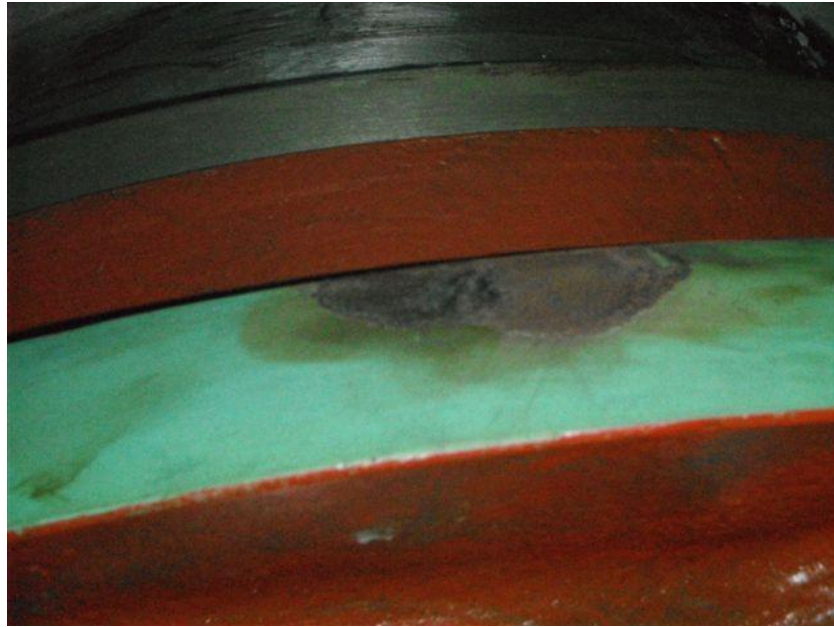
Photo # 12

Fretting marks are in evidence on both the bearing insulation (photo #12) and top bearing cap (photo #13 & 14). I measured the clearance between the bearing and the pedestal and found it to be within

spec' i.e. Outboard 0.015" and Inboard 0.018" initially it appeared that insulation had failed but after cleaning the insulation integrity was found to be good. We are uncertain why this has happened in such a short time, there are a few possibilities i.e. vibration – another resonance problem, or circulating currents, with the axial locking device removed and RTD's / Temp probes removed the insulation was good – $1\text{G}\Omega$ @ 250V. However, the probes are not insulated and there will be circulating currents going through the bearings.

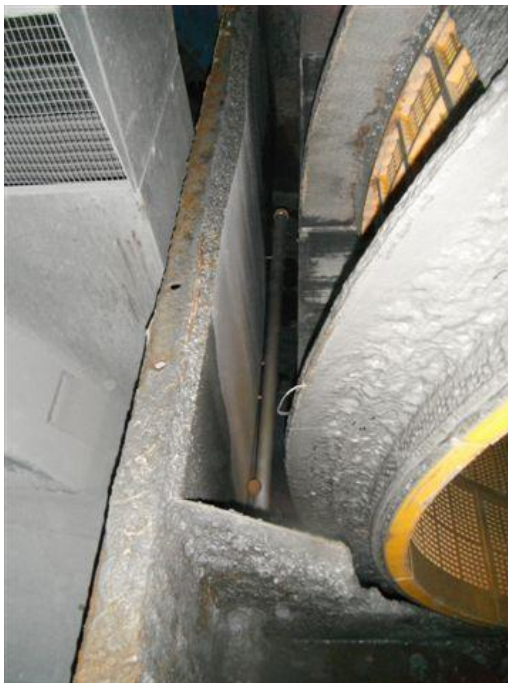
Photo # 15 is of the ball mill wall that will have to be modified at some point in time to accommodate re-torquing of the stator feet or rotor/stator air gap alignment.
