VIBETEC INC.

14th April 2011

Interim Report Compressor Motors # 6KM-2A & 6KM-2B

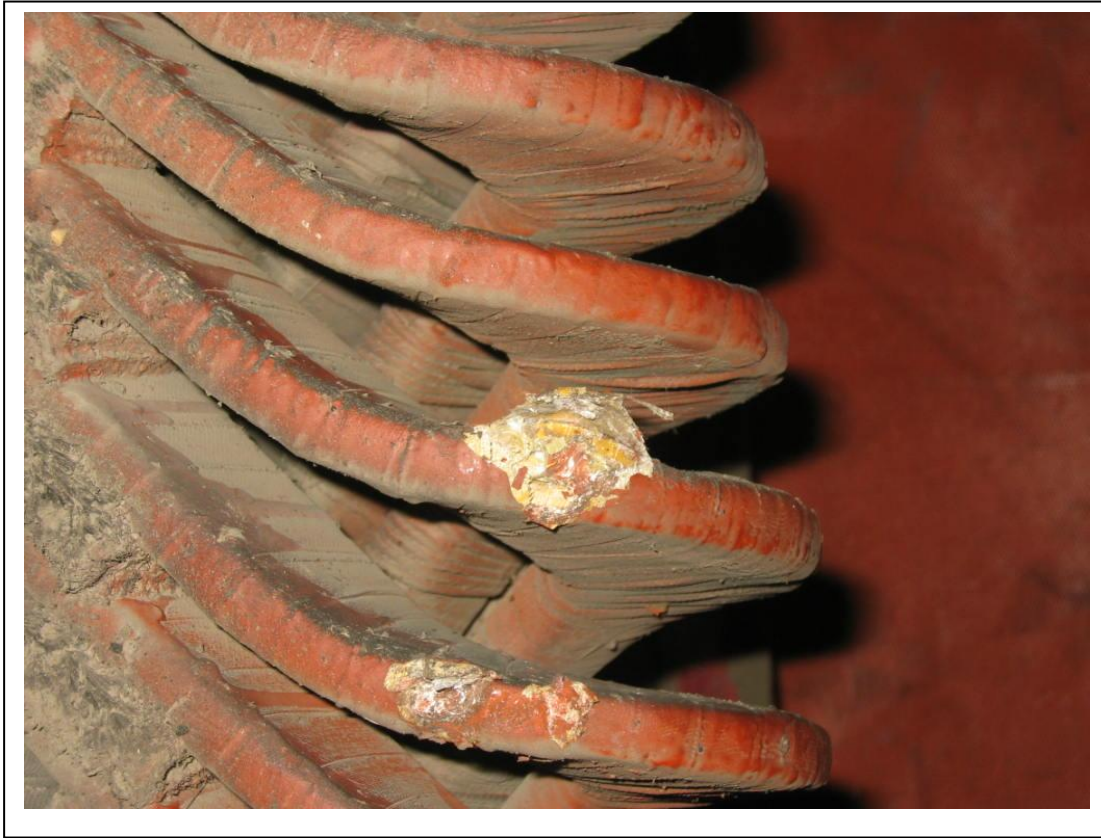
The stator windings on 6KM-2B were damaged (by others) when a shroud was dropped on them. The guard damaged three coils:

One coil had superficial damage to the outer insulation; this has been re-taped and coated with varnish.

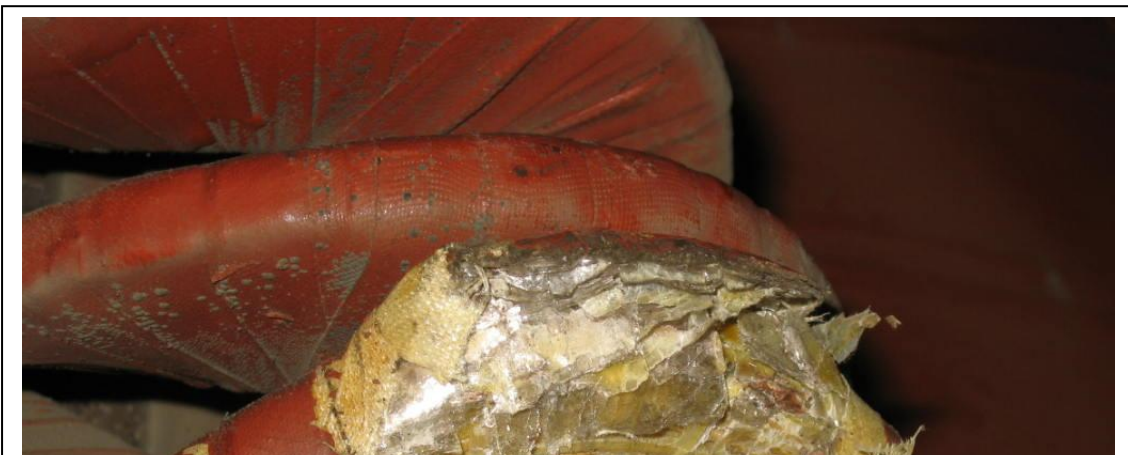
The shroud cut into the second coil cutting approx. 25% through the copper in the top turn, and caused a short with the turn below; the top turn was lifted varnished and re-insulated, the damaged area of the coil was then re-insulated and varnished.

The third damaged coil received a glancing blow; this pushed the nose of the coil to one side and tore the insulation off of the side of the coil. The coil was carefully levered back in position, re-insulated and varnished.

The winding has been successfully tested with a megger @ 5000V phase to phase and phase to ground after repair, in my opinion testing for turn to turn problems with a ducster (low resistance) meter) would not be determine the integrity of the turn to turn insulation. A surge tester could be used, but again this would not guarantee that the repair will hold up when the motor is energized; also, when using a surge comparison meter the rotor should be removed.

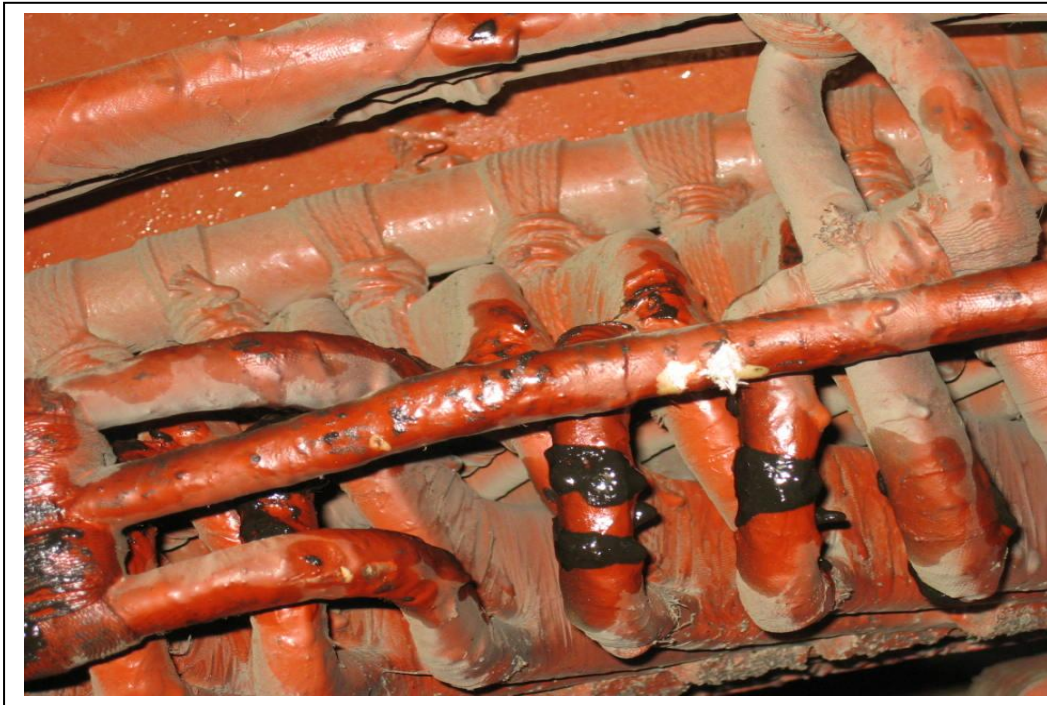
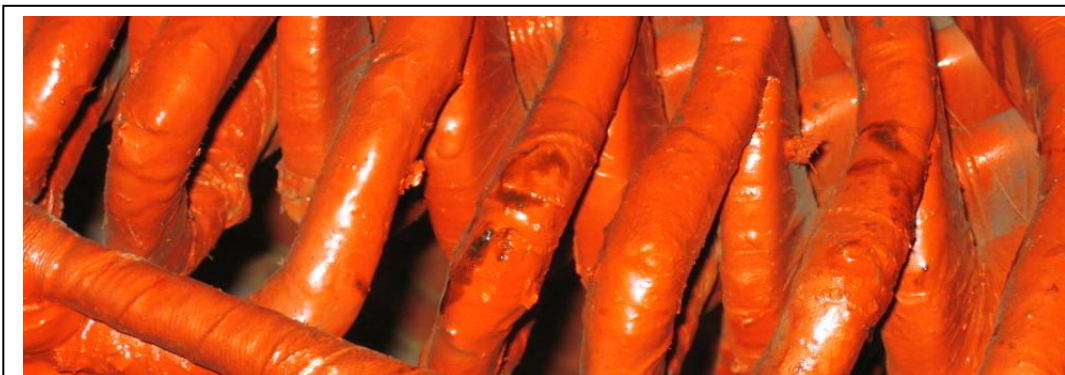
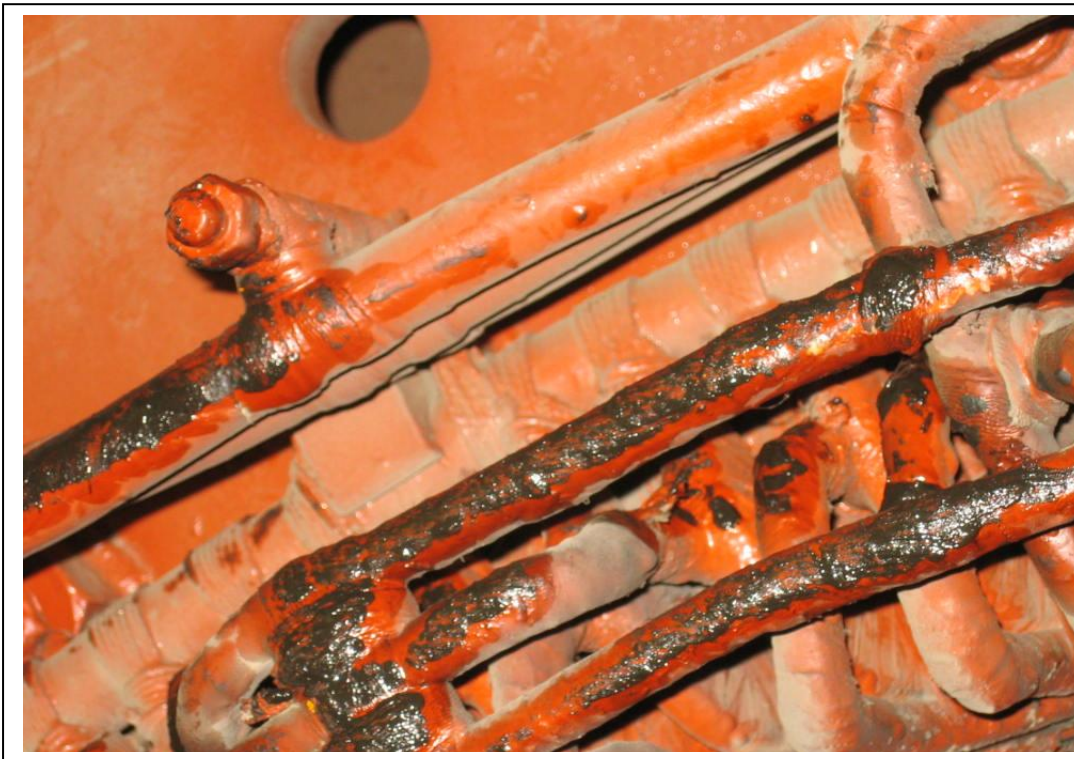
The next photographs are of 6KM-2A, this has been damaged and covered in oil because of lack of care and protection when chain falls were used to remove the shrouds. The oil has been removed with dry ice and scuffed insulation will be repaired and re-varnished with red Glyptol before the shrouds are replaced.
