VIBETEC INC.

**Regarding: Hyundai 750Hp Motor # 12353RMH263003
400 Frame 3568 RPM**

The purpose of this letter is to summarize the details of our in-situ motor inspection

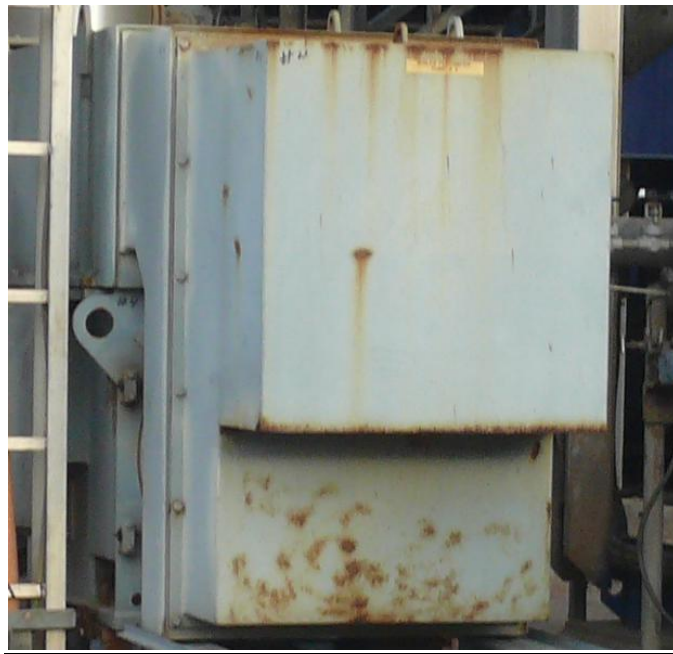
Test #3

The external cooling fan cover box had the highest amplitudes of vibration, I suspected that this could be the source of the resonance and had a hydraulic jack put underneath it to change the stiffness/natural frequency if the fan cover box.

This decreased the radial vibration on the outboard of the motor by approximately 40%; however the axial and inboard radial amplitudes increased slightly.

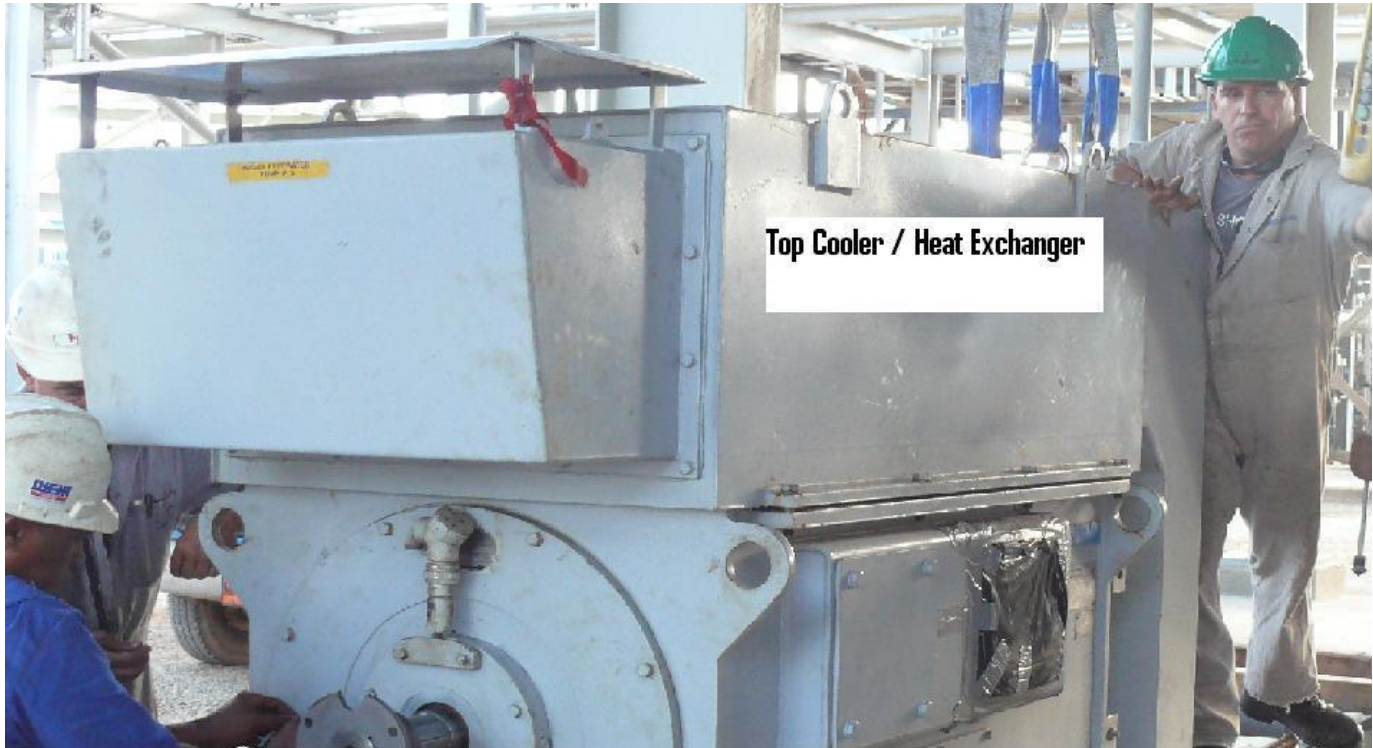
Test #6

The heat exchanger was removed from the top of the motor.

All vibration amplitudes dropped to acceptable levels and amplitudes in the vertical axis are now lower than the horizontal.

The highest vibration amplitudes now emanated from the outboard bearing in the horizontal plane @ 0.14 In/Sec. I suspected that this remaining vibration amplitude was due to slight rotor/fan unbalance. With the knowledge that the main vibration issue was resonance, obtaining an extremely low balance quality would reduce the resonance exciting force.

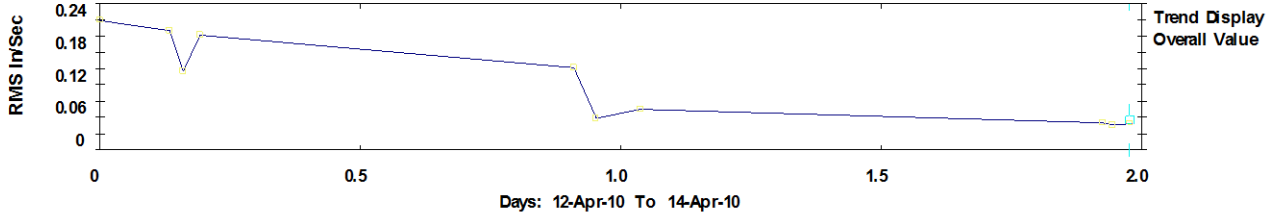
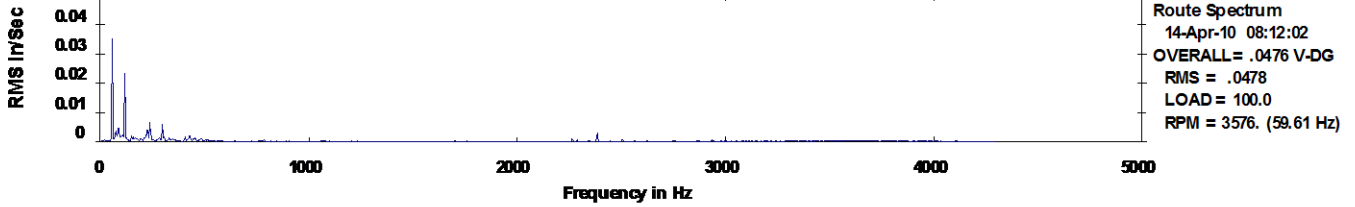
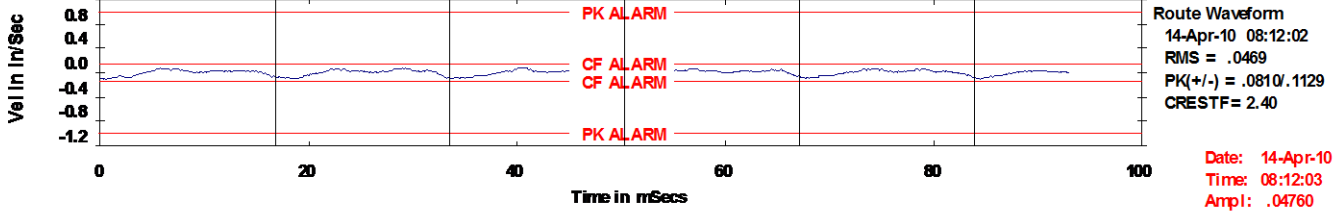
FWP - Feed Water Pump #2
FWP 2 -MOV MOTOR OUTBOARD VERTICAL

The spectrums and waveforms are with the motor coupled and under load.

The high vibration levels are a result of resonance emanating from the heat exchanger on top of the stator. Considering that the vibration amplitudes change with slight adjustment of the heat exchanger and with temperature variation, would suggest that there is something damaged within the heat exchanger, possibly a broken weld on a cooling tube. Whatever is damaged within the heat exchanger is bringing the motor into a resonant frequency when it is secured tightly on top.

Leave the heat exchanger with the bolts in place but not tightened. There is enough weight in the exchanger to create a seal between the motor and exchanger.

Try to repair the heat exchanger, Hyundai may be able to issue a schematic diagram (this could be proprietary information and not available), of the internal construction of the exchanger this would help a feasibility decision to be made.

Purchase a new heat exchanger.

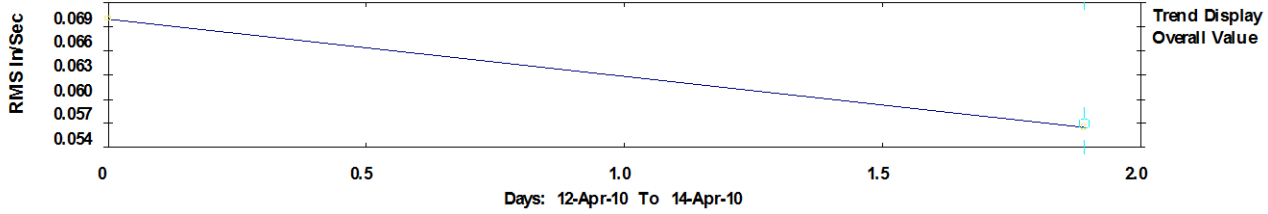
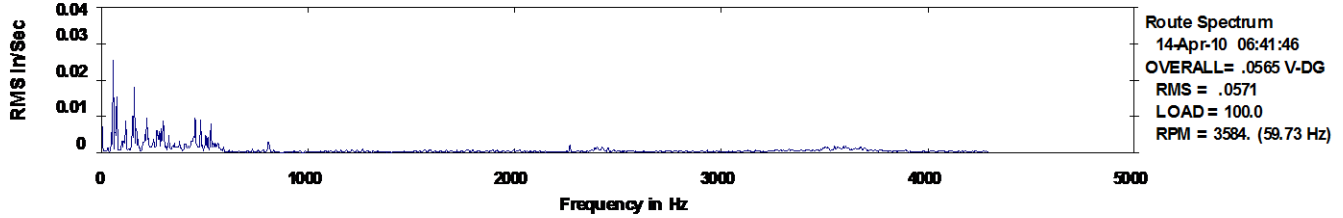
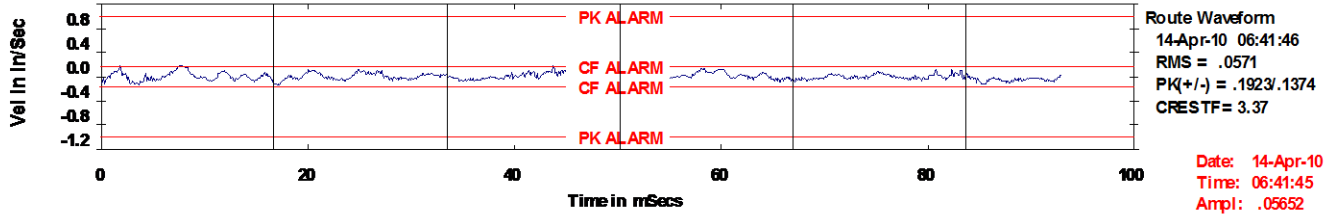
FWP - Feed Water Pump #3
FWP 3 -MOV MOTOR OUTBOARD VERTICAL

I analyzed all four feed water pumps, 1 & 4 are in good condition and pump #3 is in fair condition, however all motors have relatively high vibration amplitudes in the vertical direction. Pump #3 has the highest levels of vibration 0.73 in/sec (Motor Outboard Horizontal). When the heat exchanger was loosened all radial vibration levels dropped in amplitude. This is probably an early indication of a similar problem starting to occur.
