VIBETEC INC.

#5 Dryer Circulating Cooling Fans

The following report is based on data collected on the 26th Feb 2011:

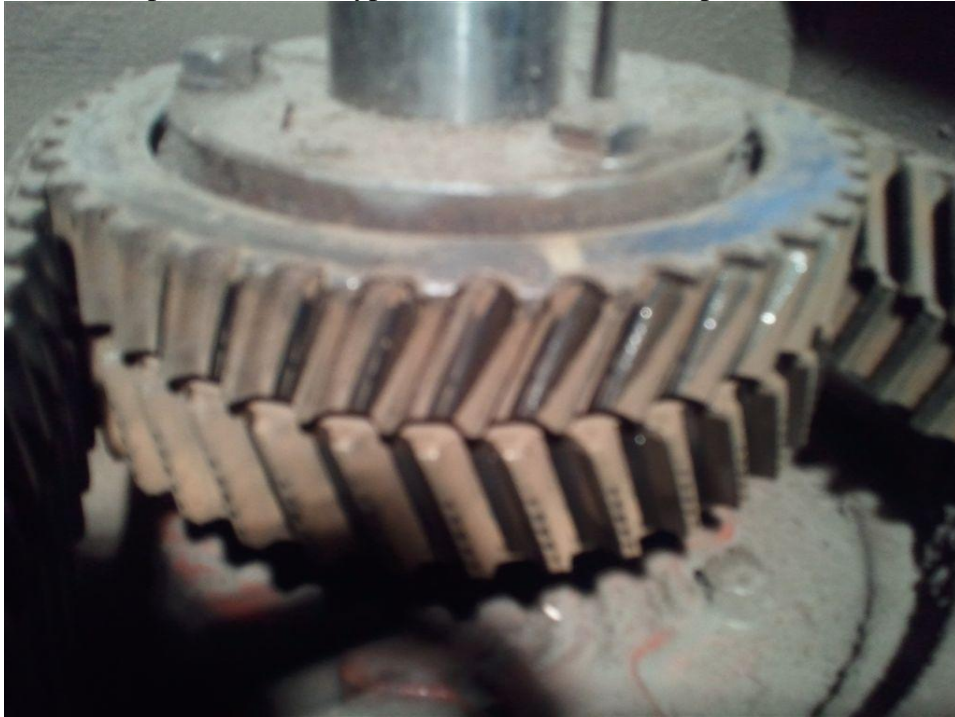
When checked, all of the motor belts were found to be out of spec' and 3 or 4 were misaligned, all of the sprockets on the motors are worn and should be replaced. A new belt has been installed fan #24, all of the belts set to the correct tension (37.5 Hz for new and 31.7 Hz for used), and sheaves aligned.
 N.B. The recommended belt tension for used belts adds another exciting force for the resonance.

The worn teeth shown in the photo below is typical of all of the motor sprockets:

Install all new motor sheaves and belts as necessary.

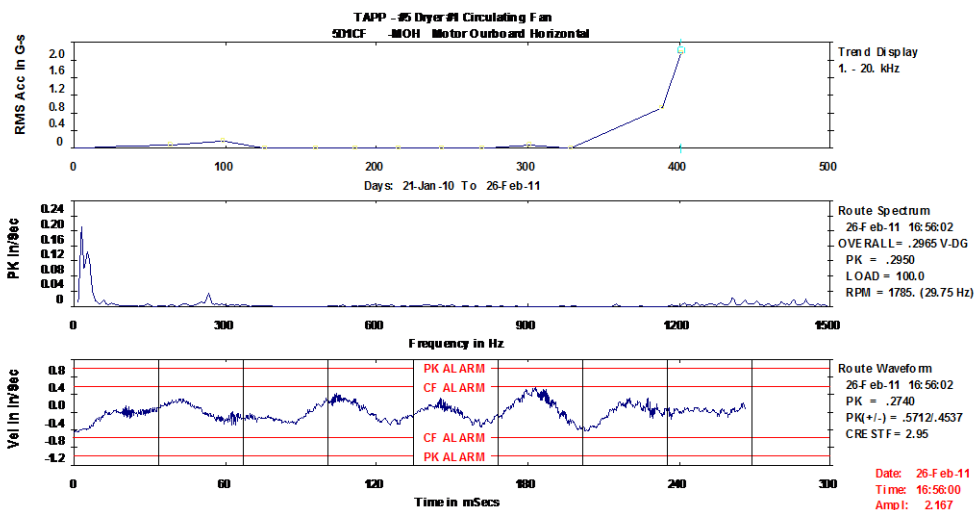
Now that the overall amplitudes have decreased on the majority of the fans, It was possible to detect other issues i.e. the motor bearings on fan #1 are defective and the motor should be serviced, the motor bearings on fan #17 are deteriorating and as a minimum greased ASAP, if this is not possible (the bearings could be the “sealed for life” type) service the motor.

Service motors # 1 and # 17.
