# VIBETEC INC.

## Vibration Analysis Report

The following report is based on data collected on the 27<sup>th</sup> Mar 2010:

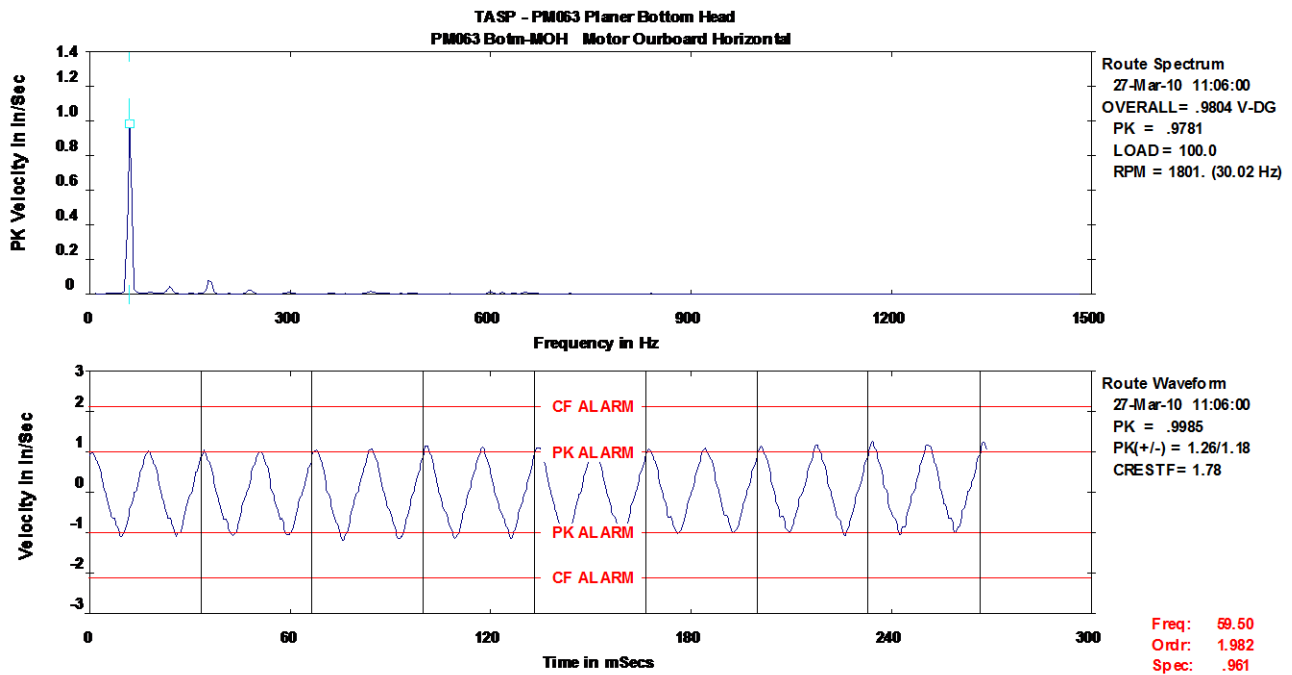
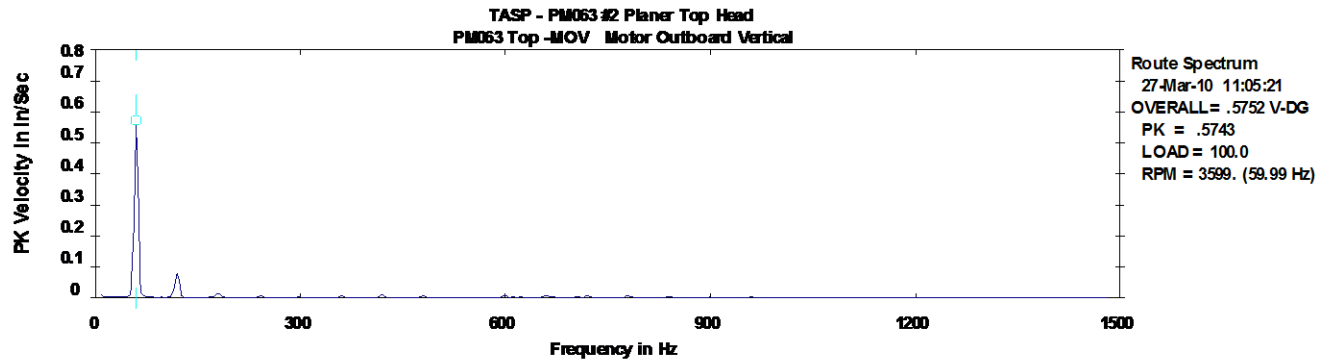
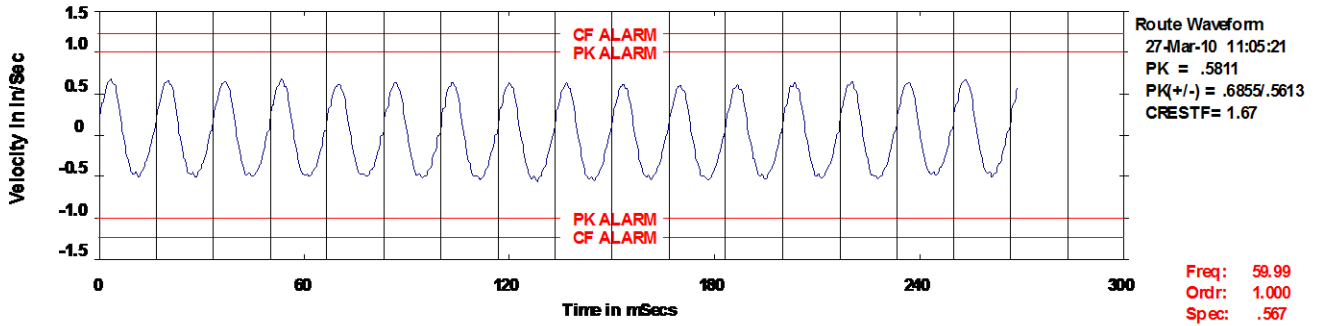
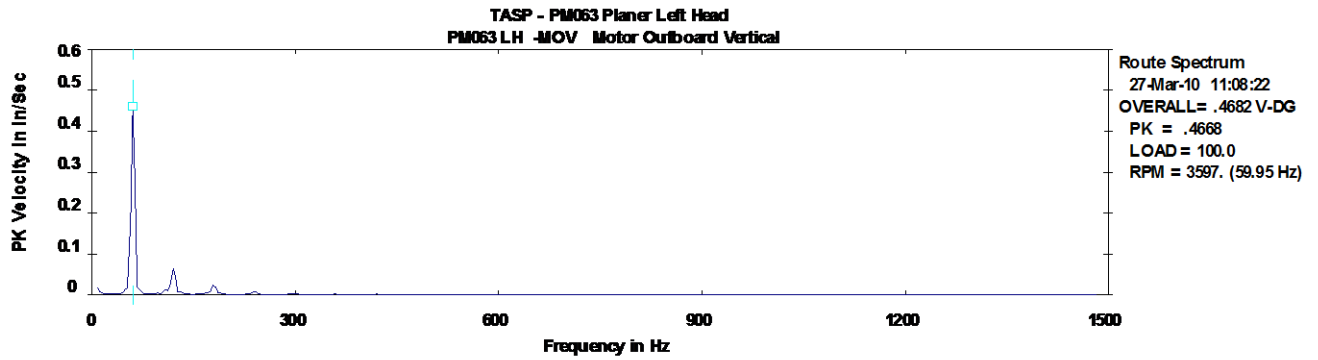
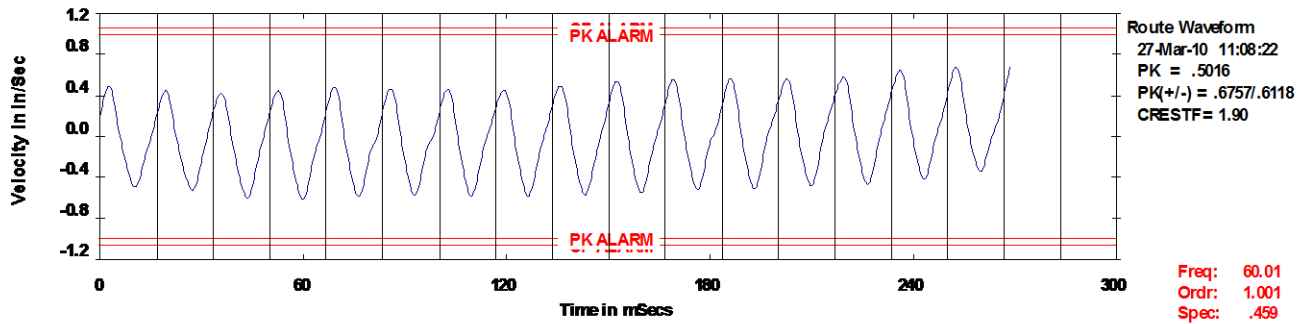
### 1/ SM 063 #2 Planer Bottom Head, Top Head & Left Head

The bottom and to a lesser degree top and left and heads are unbalanced check for damaged or contaminated blades, if nothing is found the bottom arbor should be balanced.

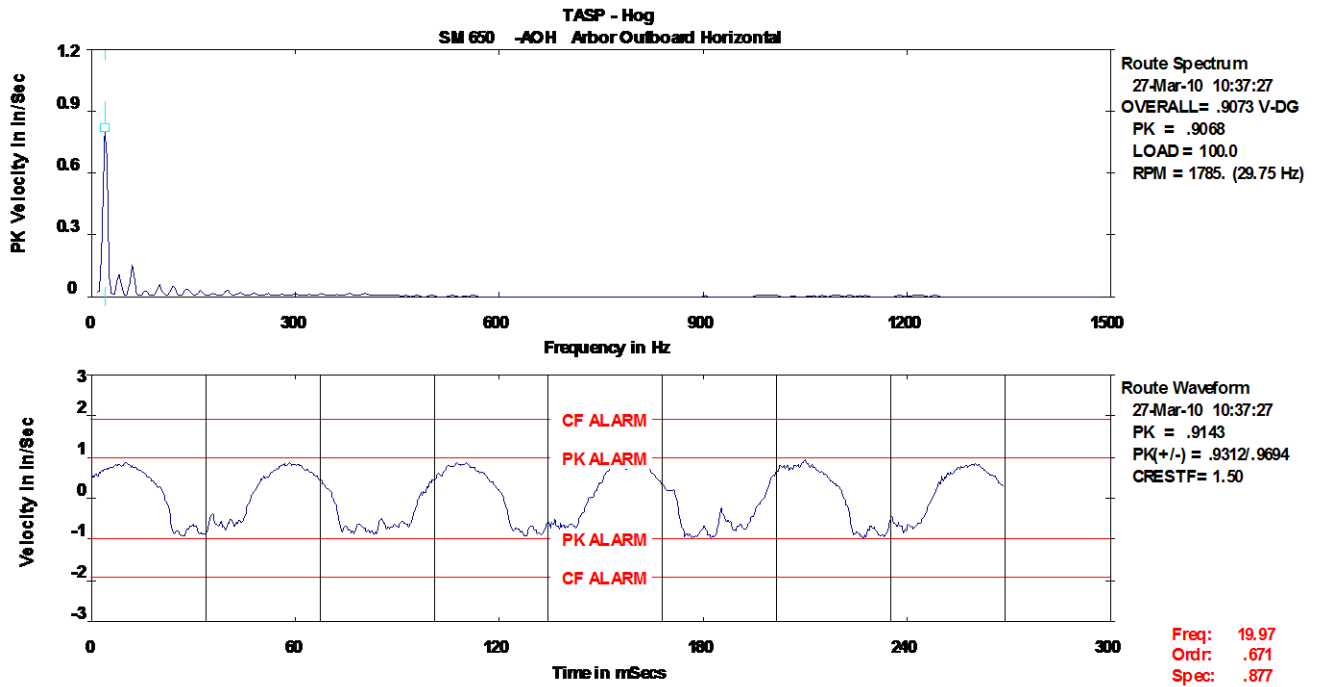
2/ SM 650 Hog

The hog arbor is unbalanced - check for damaged or missing hammer.

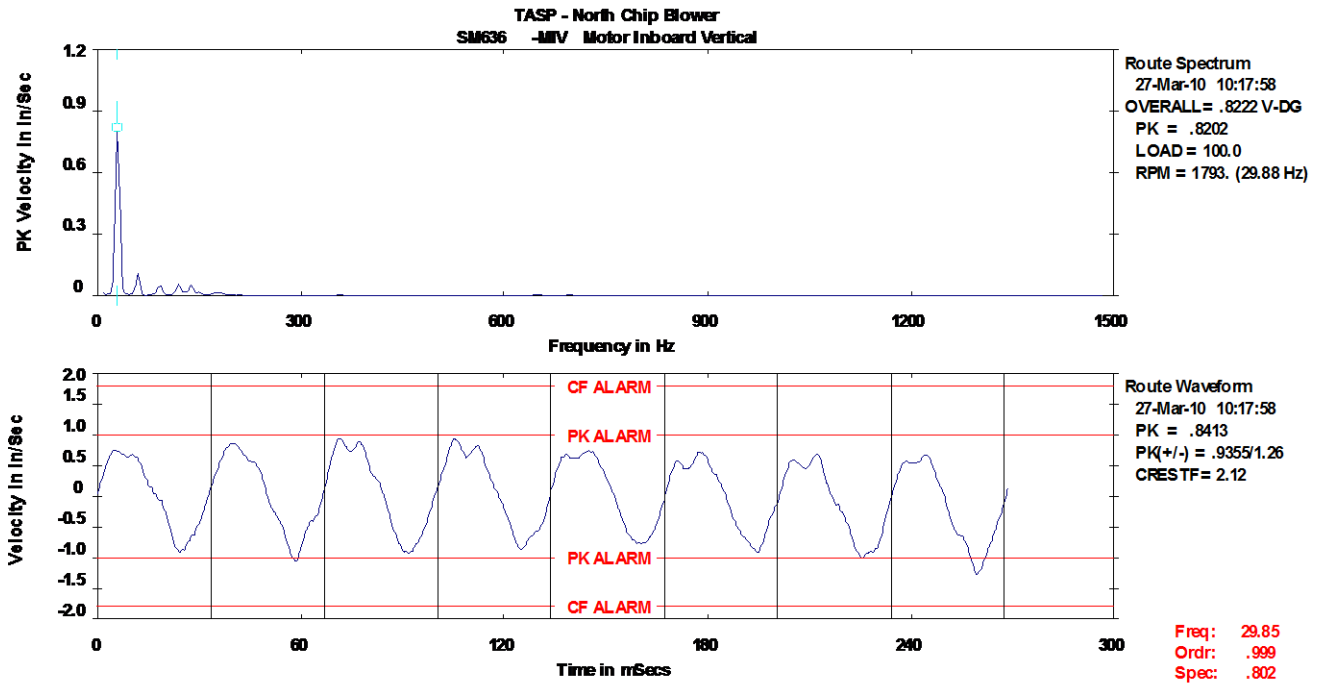
### 3/ North Chip Blower

The drive end (inboard end) of the motor appears to be unbalanced – check for a damaged or contaminated sheave.

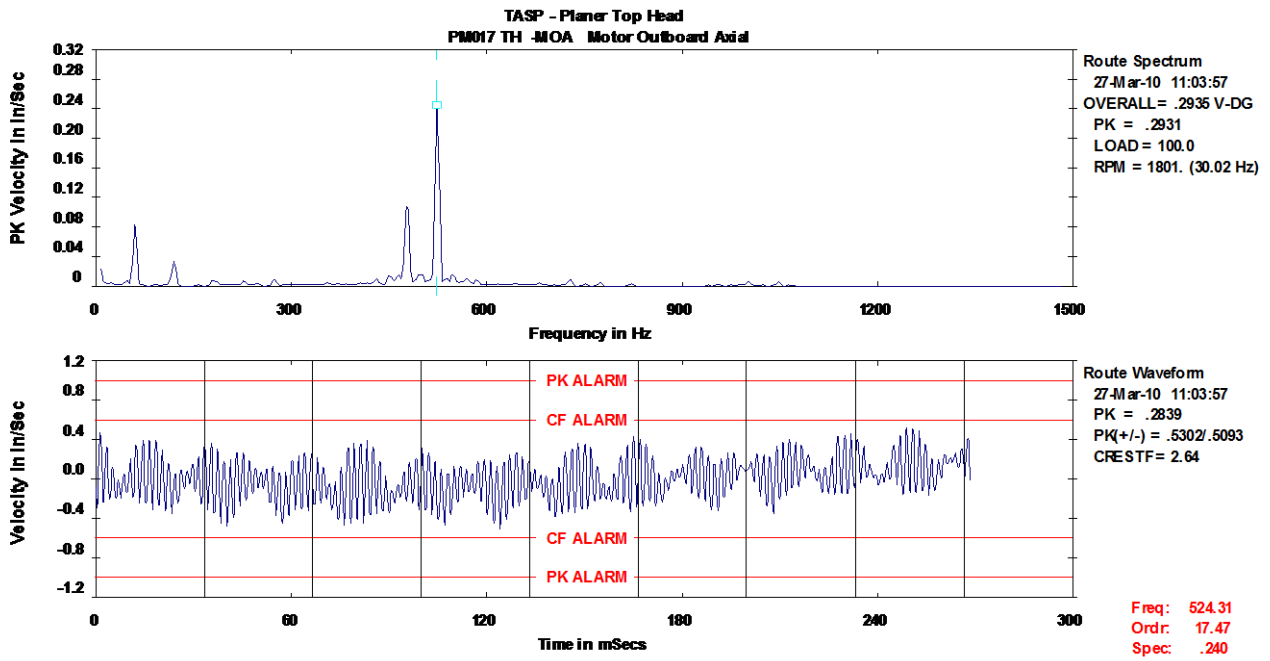
### 4/ PM 017 Planer Top Head

There are early indications of motor bearing wear – grease the bearings and I'll check for any further deterioration next month.

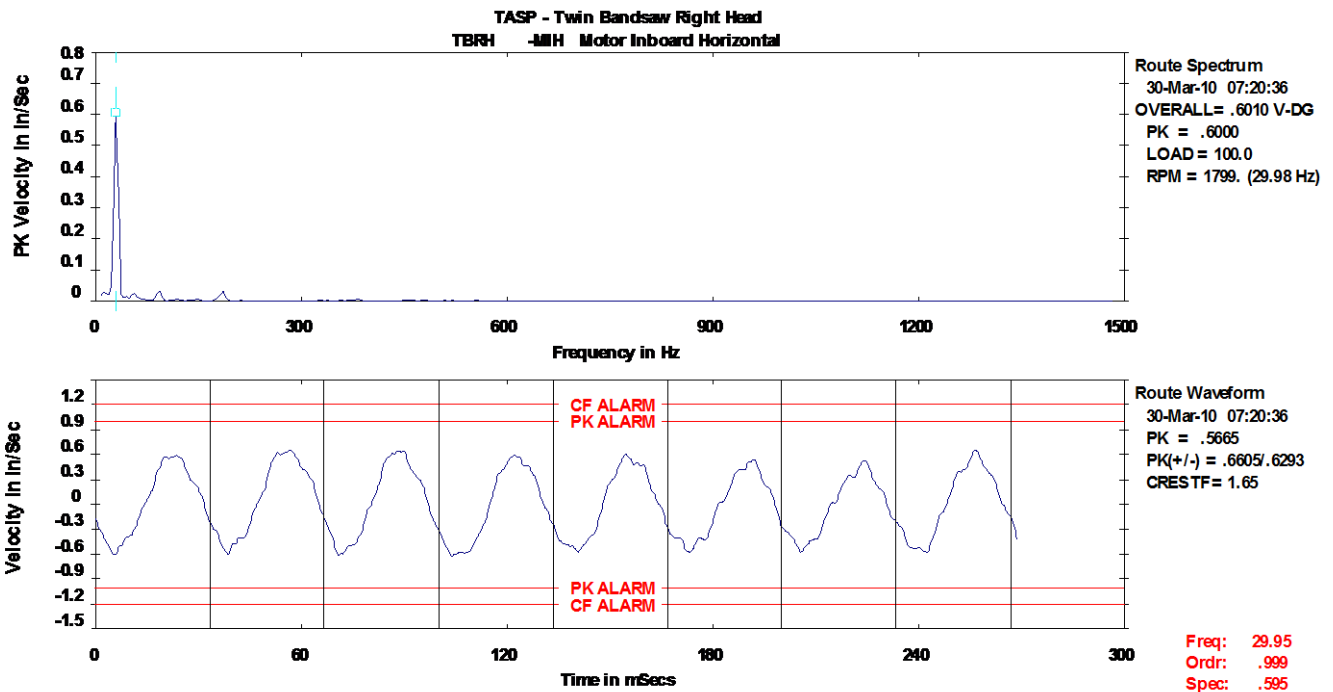
5/ **Twin Band Saw Right Head** (Dave please email back with the Plant # )

The motor is unbalanced; any equipment with an rpm over 1000 and/or a width more than 50% of the diameter, should be dynamically balanced (i.e. two planes). It might be possible to reduce the vibration on one plane (i.e. the sheave), but if the vibration is not causing a problem with product quality, I recommend that the motor is balanced in a shop with the sheave in place during a shutdown.

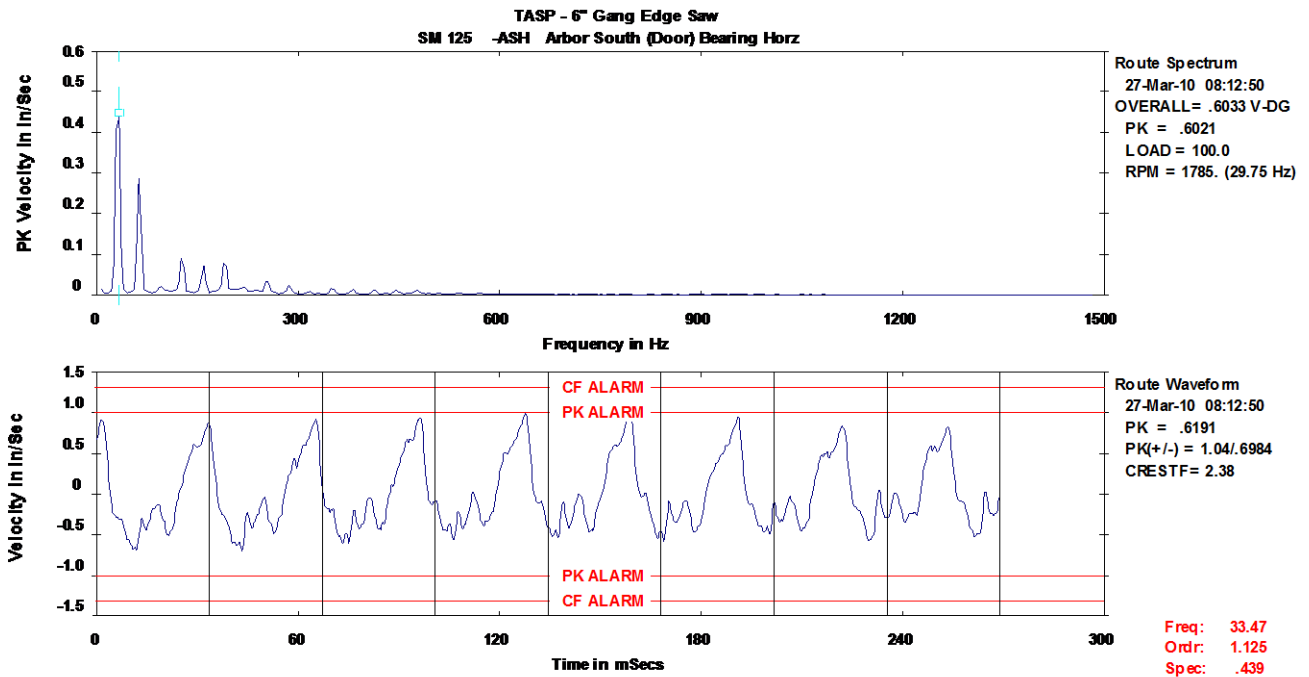
6/ **SM 125 6" Gang Saw**

The door bearing is misaligned, the bearing is in good condition but will soon deteriorate if this is not addressed. I have seen this problem before and as I explained to Rick, I found that the best way to ensure that

the bearing runs true in the door housing is to use a dial indicator; i.e. center the magnetic base on the end of the arbor shaft and rotate the shaft with the needle on the face of the bearing outer race, then make adjustments until there is no deflection.
