#1 ID Fan

Babbitt Bearing Installation

Bearing Horn Clearances – as found

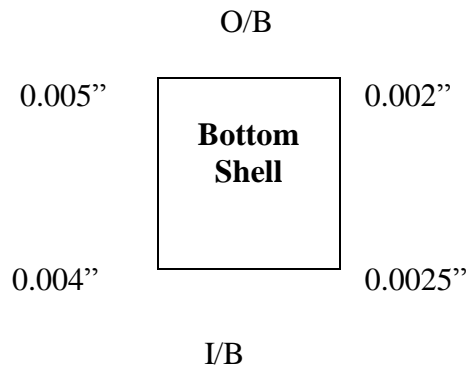
Inboard Bearing (North)

The horn measurements are taken with the bottom shells in the pedestals, Persian blue was applied to the shaft and the shaft rotated 360°. The bearing was found to have insufficient side clearance and had to be scraped.

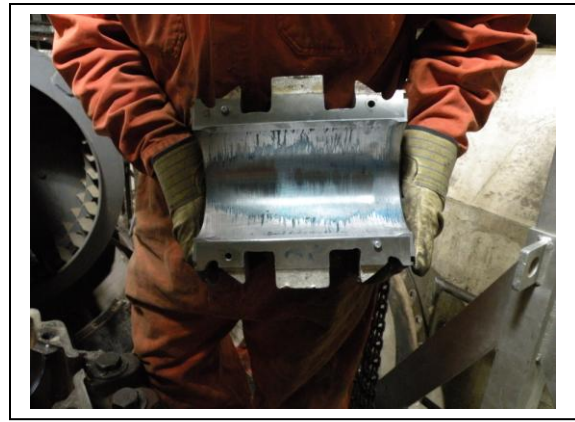
Through experience I have found that along with the minimum 75% bottom contact, if the ends are scraped so that a "lemon shaped" pattern is achieved the oil drains quicker and the bearing runs cooler.

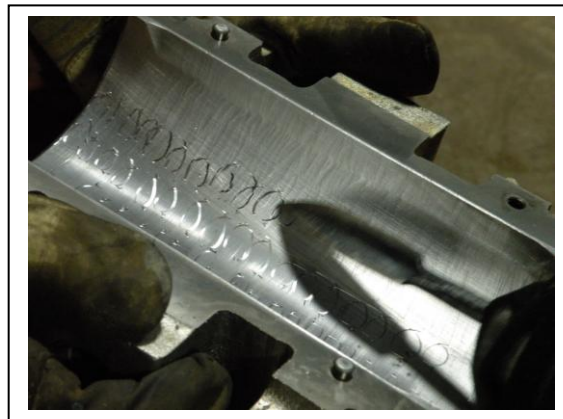
When the correct “fit” is achieved the bottom bearing shells are scored (frothed), this helps to create the oil wedge quickly.

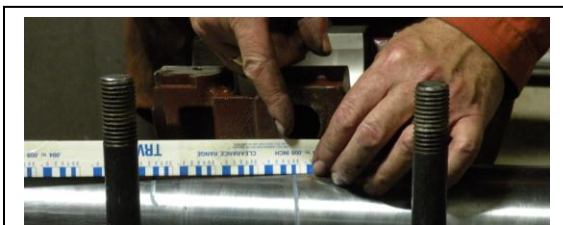
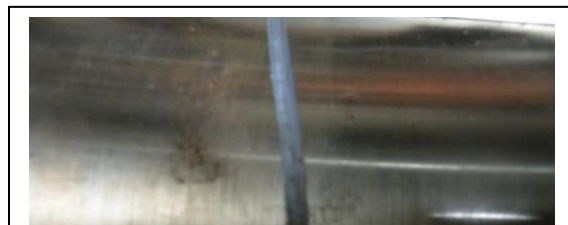
With the bottom shells installed into the pedestals the top shell internal clearance is measured either with lead or plasti-gauge:

Inboard (North) bearing top clearance: 0.008”
Outboard (South) bearing top clearance: 0.007”
