VIBETEC INC.

19th June 2011

Ball Mill Pedestal Vibration

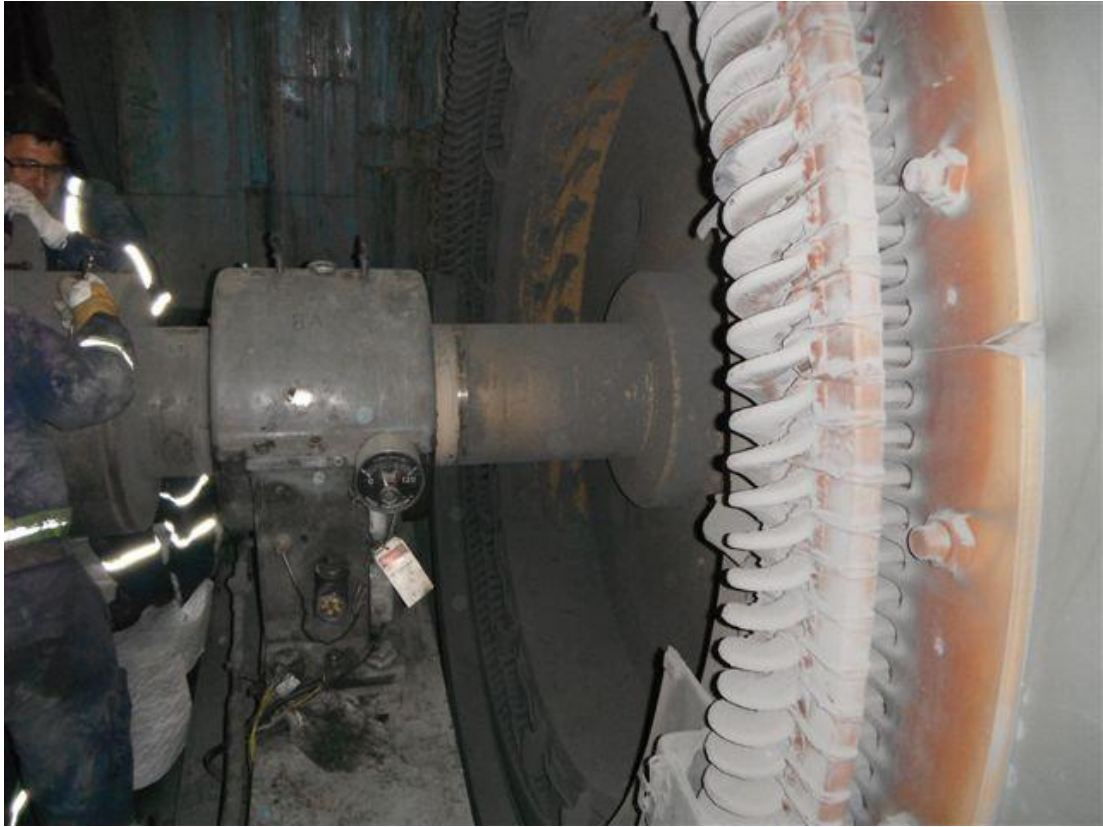
Photo #9

The width of the pedestal is 20" and the space between the pedestal and rotor with the guards removed is 22", this will enable easy removal/replacement of the drive end pedestal. However; the hoist rope could conceivably rub on the stator windings and provision should be made to protect them. With the rotor shaft jacked and blocked and labyrinth seals removed, the bottom half of the pedestal could be moved along the shaft with the hoist and with the aid of come-along attached to one side lowered and swung from beneath the shaft.

Note: in addition to the babbit bearing and pedestal replacement a new oil ring should also be installed.
